TURANGAWAEWAE HOUSE
Maori Parliament Building
2 Eyre St
Ngaruawahia

CONSERVATION PLAN

BURGESS AND TREEP ARCHITECTS
December 2007

TURANGAWAEWAE HOUSE KAUHUNGANUI 2 Eyre St NGARUAWAHIA

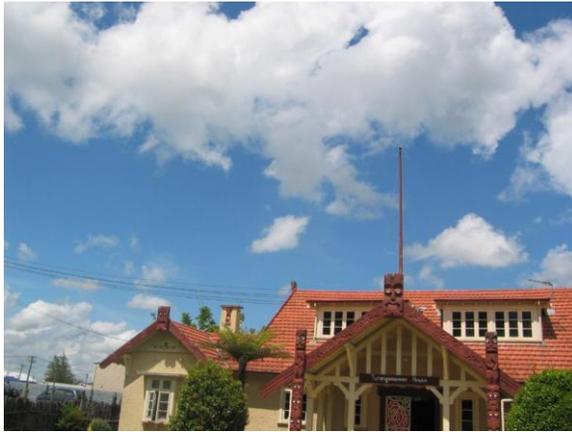
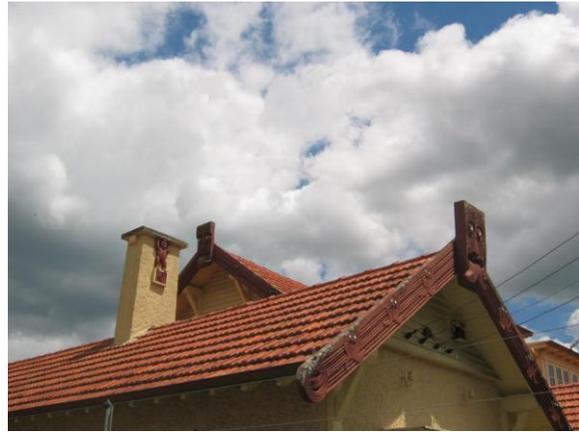
Roof forms from the road. Photo: Graeme Burgess, 2006.

The use of carved Maori design elements on the gables and the tekoteko plastered on the chimneys gives a uniqueness to the roof forms that is intimately tied to its ownership and function.

CONDITION NOTES: A survey of the roof has been carried out by Jarrod Gillespie of MacMillan Slaters & Tilers, There are several areas where the effects of time and activity on the roof have caused problems. This is discussed in the condition section of this report, Section 2, 2.4(iv) Physical Condition. Mr Gillespie has set out a range of options for the repair and maintenance of the roof and this is attached as Appendix 9

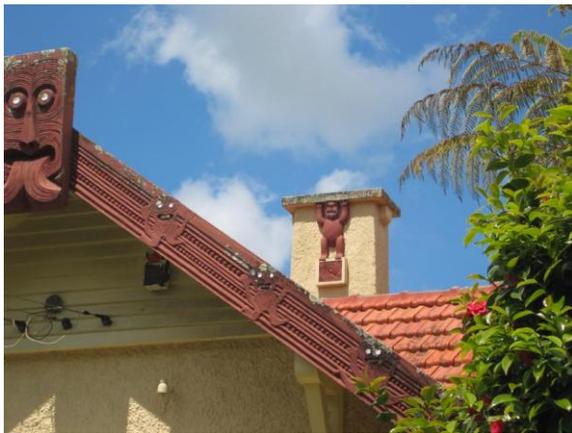
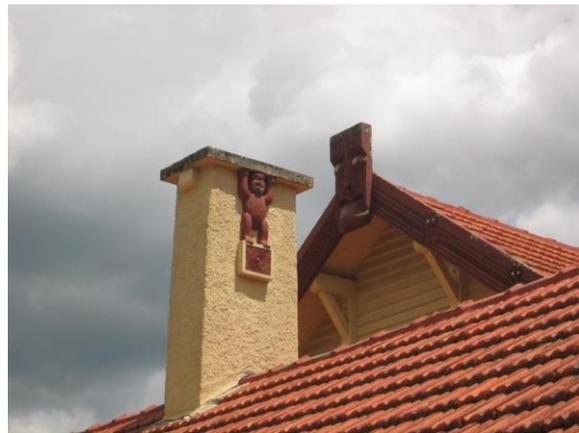
*Gable end, koruru figure & carved maihi, plastered tekoteko on chimney behind
Photo: Graeme Burgess, 2006.*

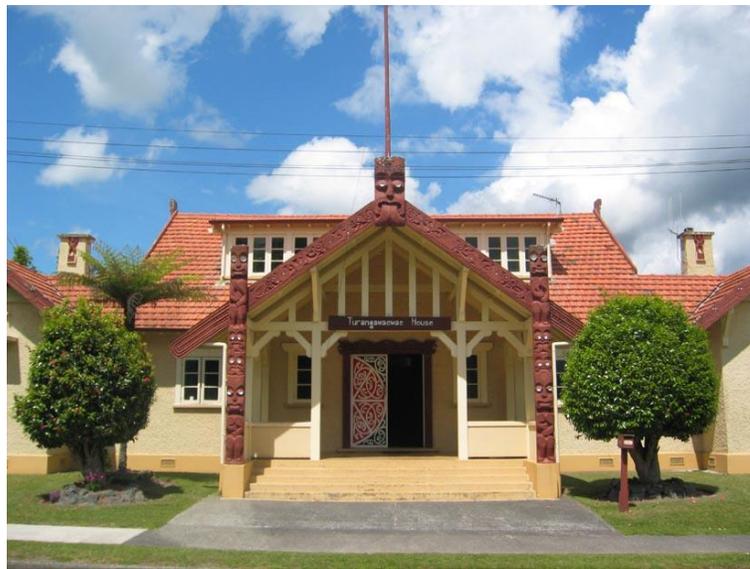
Entry porch. Photo: Graeme Burgess, 2006.

The entry porch is labelled on the architectural drawings as “Piazza”. From the street a concrete pathway the full width of the entry porch leads up to its painted concrete steps. These are set within the overhang of the roof structure. On each side are plastered concrete plinths, extending out level with the porch floor, and in line with the step detail at the base of the rest of the building that defines its base. The floor of the porch is plastered concrete. The faces of the posts on either side support carved amo. These project above the maihi. This entry

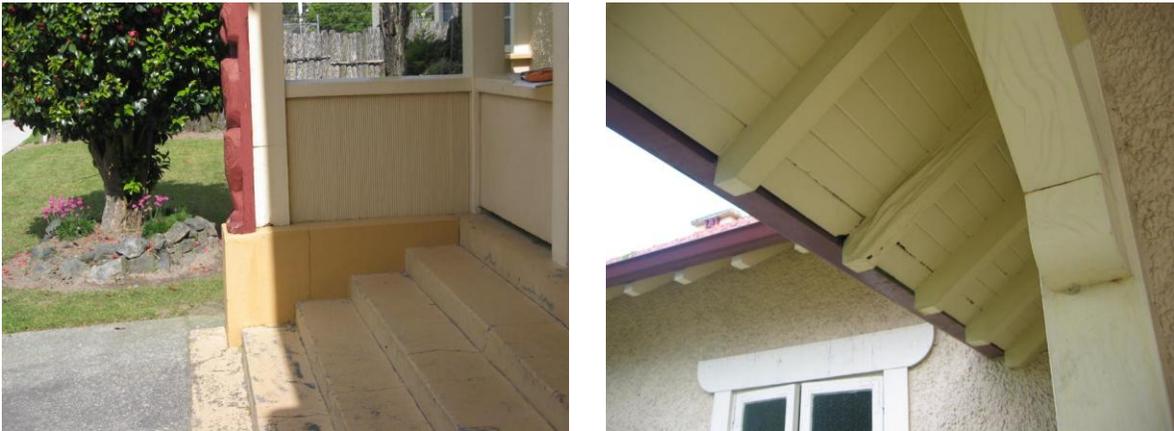
left: steps and side detail, note the post repair, right soffit detail, note decayed rafter photos Graeme Burgess.

CONDITION NOTES: The outer posts of the entry porch have been cut and repaired. One of the porch rafters has substantially decayed. The barges have slumped slightly

and the exposed timber soffit structure has been removed to the right hand side of the entry porch.

Timber rot at the base of the left hand post of the entry porch, and one rafter supporting the left hand side of the entry porch.

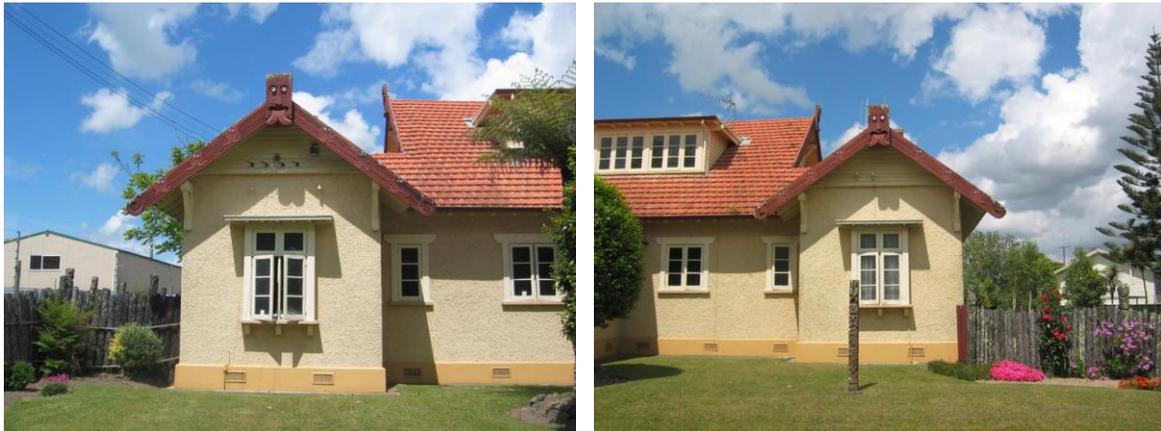
*Left, eastern side gable. Right, western side gable.
Photo: Graeme Burgess, 2006*

The side gables each have a central pair of casement windows set in a very shallow bay. The bay projects at cill level and is supported by 3 radius ended timber modillions. The window is capped with an eyebrow roof supported by exposed flat rectangular section rafters and finished by a slightly smaller plain fascia. The roof is painted metal. The gable end is finished in weatherboards, belled out at the lower edge. There is a narrow exposed cable duct run up the face of the right hand gable, and above this on the weatherboards of the gable end is a pair of ceramic isolators at the point where the power cables once entered the building. The overhead wires now enter through the left hand gable end. Here there is a set of four isolators and a related electrical box, and also a rusty alarm box. Below projecting from the stucco wall are two remnant metal fixtures that swan-neck out from the wall.

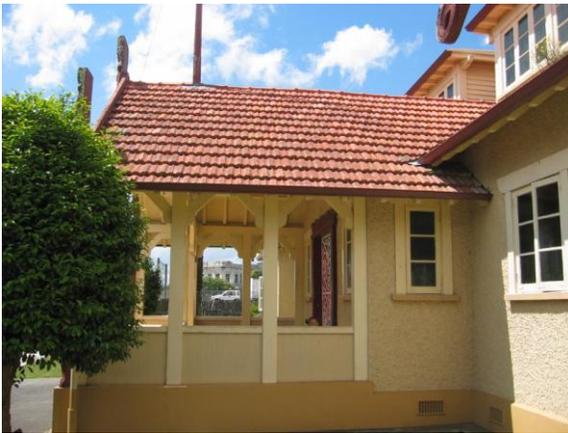
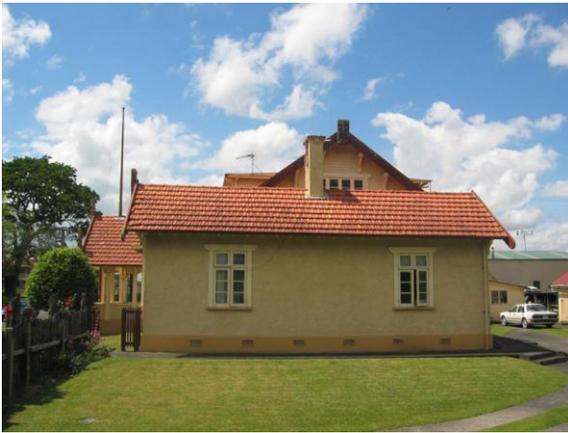
Photos Graeme Burgess, drawings original plans Warren & Blechynden

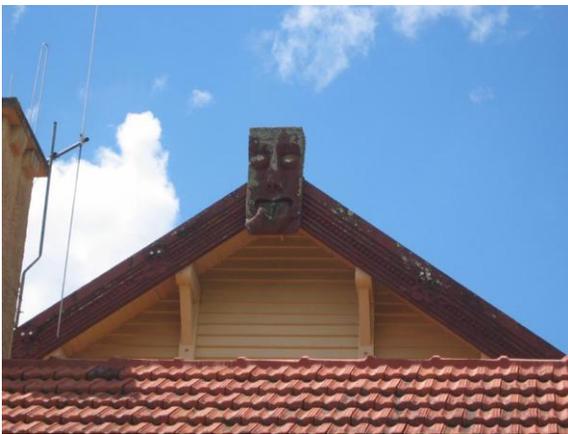
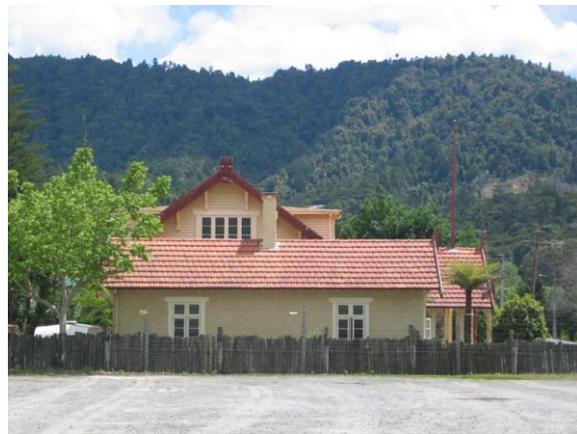
Left: Western gable end of the Chamber, right: view of eastern side of Turangawaewae House across the neighbouring property. Photos: Graeme Burgess

CONDITION NOTES: some areas of repaired cracks at the south western corner, slumping beneath the pathway in this area. Refer Section 2, 2.4(iv) Physical Condition.

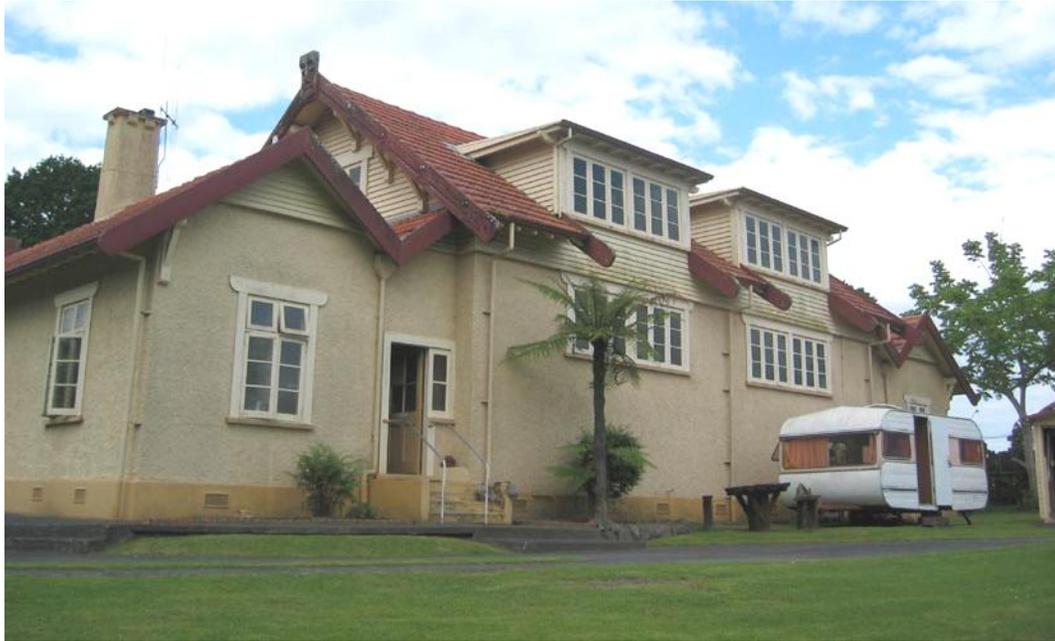
Rear of the building, Warren & Blechyden drawing. Photo Graeme Burgess.

This is the back of the building and is also symmetrical about the centre axis. The side gables zigzag up to the outside of the “Chamber”, and the mass of the “Chamber” roof is split by the two wide dormers that rise up in line with the outside wall. The eave of the “Chamber” is high, its position defined by the internal relationship of the spaces as the side walls of the “Chamber” relate back to the even slope of the roof at the front of the building and the matching slope of the roof on the return sides of the passageway, expressed here as the upward slope of the valley between the side gables and the “Chamber”. The

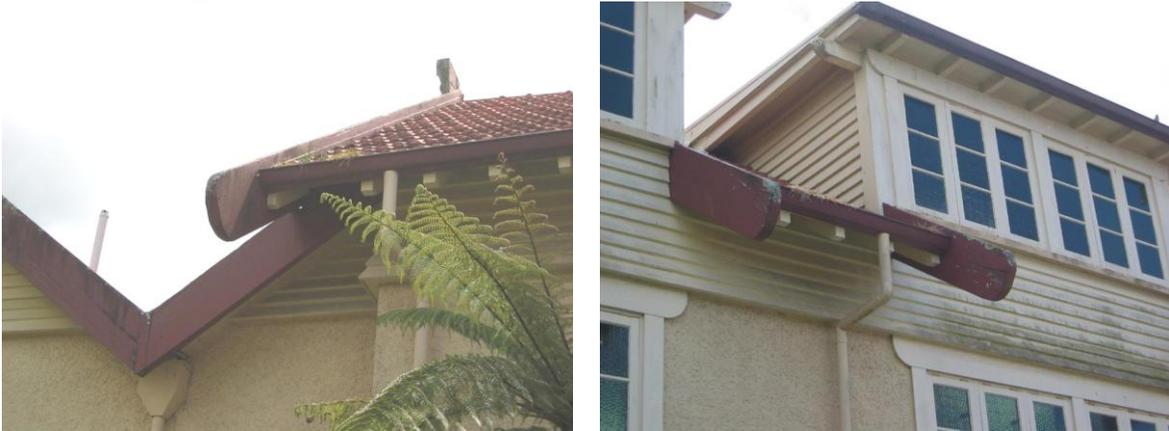
left: valley intersection with rainwater head behind, right: eaves between the clerestorey/dormers. Photos Graeme Burgess

CONDITION NOTES: At the south western corner right through to the entry way there have been repairs to the exterior plasterwork indicating settlement in this area. At the rainwater outlets the soffits are damaged and some timberwork needs

replacement. The barges have separated at intersections and pulled out from the face of the roof. Refer Section 2, 2.4 (iv) Physical Condition.

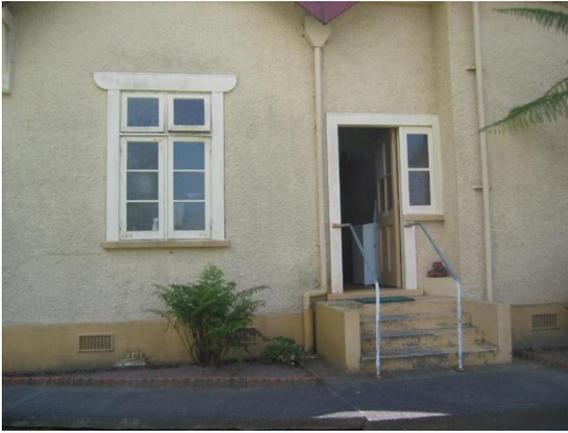
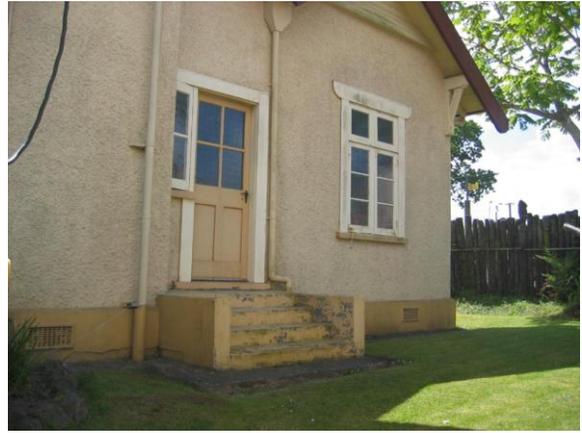
left entry to west passageway, right entry to east passageway, photos Graeme Burgess

The side gables each have a paired casement windows, matching those on the east and west sides of the building. On either side of the “Chamber” there are plastered concrete steps set within low plastered concrete walls. These lead up to the door into the former toilet area at the end of the passageway. The door is a panelled timber door with two sunk panels beneath the lock rail and a glazed upper panel in four lights with glazing bars between. On the “Chamber” side of these doors is a small casement window at the head height of the door, with a single glazing bar across it. At the western doorway there is a solid concrete plinth beneath the window, angled out to the face of the “Chamber”. The facings frame both the door and window. The facings are square cut and do not overhang.

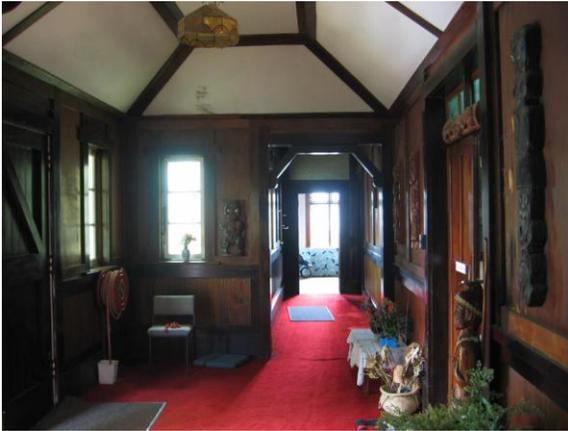
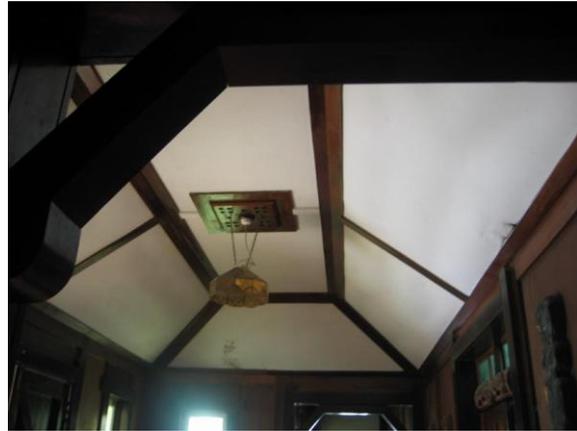
Photos Graeme Burgess, drawing Warren & Blechyden.

Problems: water damage to panelling at right hand side of the door to the Chamber. Water and mould damage to the sloping ceiling panels at eastern end of the room. Fire hose reel.

CONDITION NOTES: water damage to panelling at right hand side of the door to the Chamber. Water and mould damage to the sloping ceiling panels at eastern end of the room. At the north eastern corner the roof junction above has failed. The timber framing in this area requires repair.

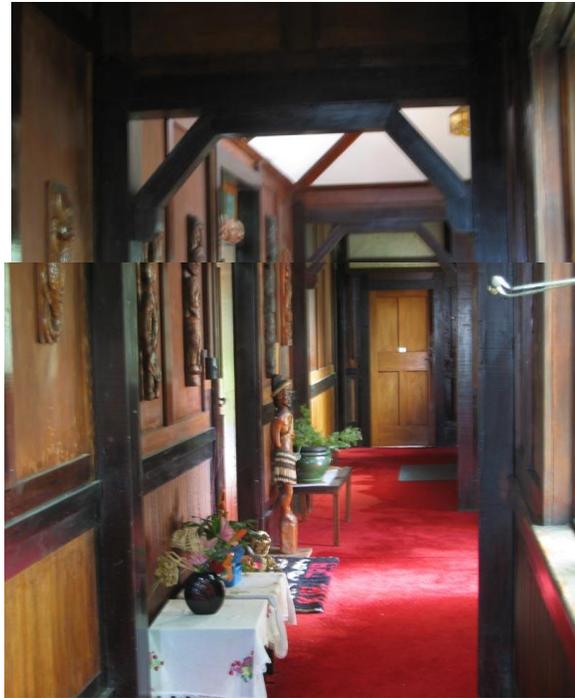
Photo Graeme Burgess, drawing Warren & Blechyden.

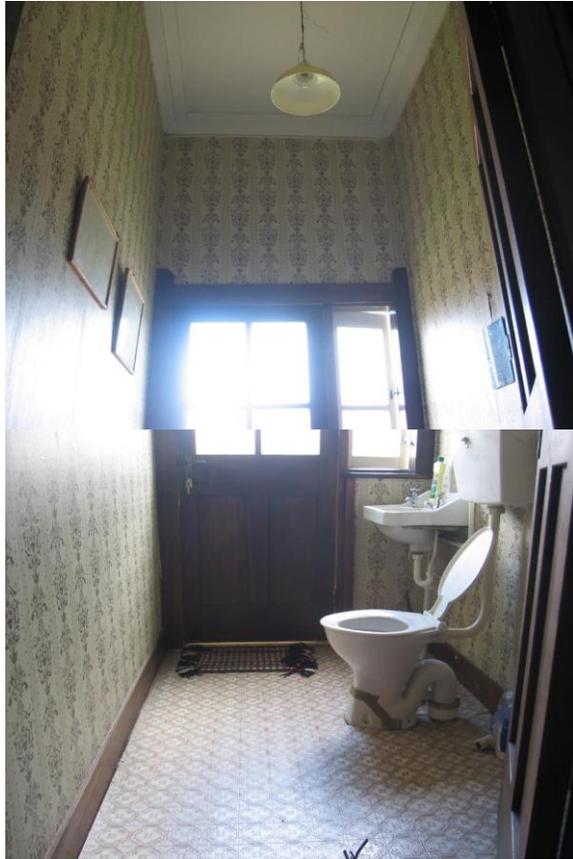
Toilet; south end of eastern passage, photo Graeme Burgess

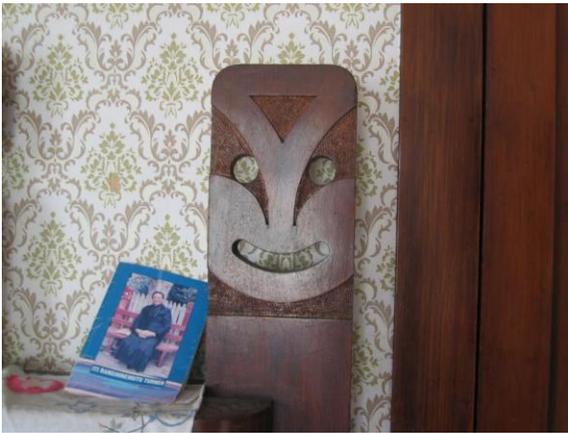
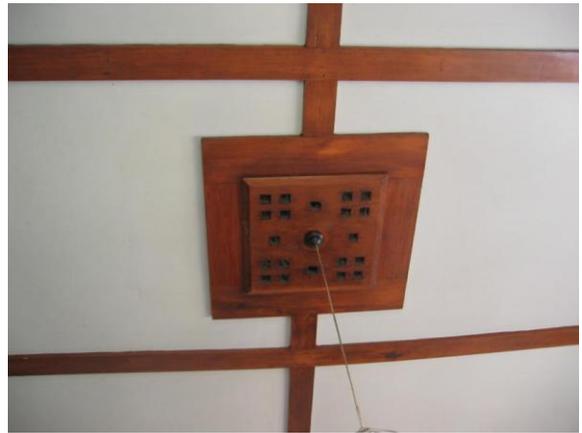
The side wings of the building contain the private rooms, noted on the plans as “Minister’s Room” on the north western corner, and “Leader of Opposition’s Room” at the north eastern corner, both with “Clerks Rooms” behind them. All these rooms are similarly finished: the skirtings in these rooms are smaller flat boards, the walls are wall papered, the cornice is a plain angled board, the ceilings are panelled and feature square ceiling roses set on the panelling. The ceiling roses have square ventilation holes. There is a fireplace in each room. The fires are cast iron registers with tiled surrounds set within plain board mantelpieces. These have strong vertical boards at each side finished in simple and delightful tekoteko. The register has been removed in the north west room.

*Left tekoteko decoration on fireplace surround, right ceiling rose.
Photos Graeme Burgess.*

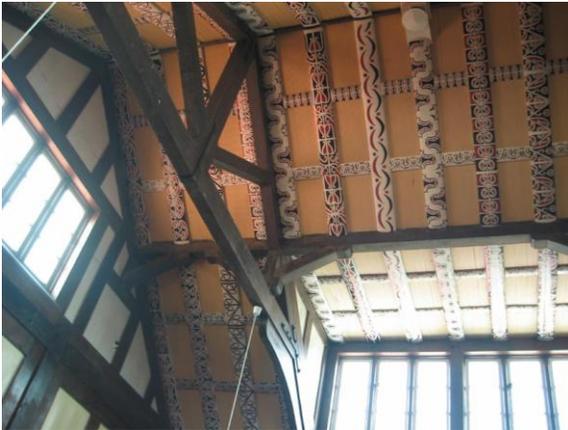
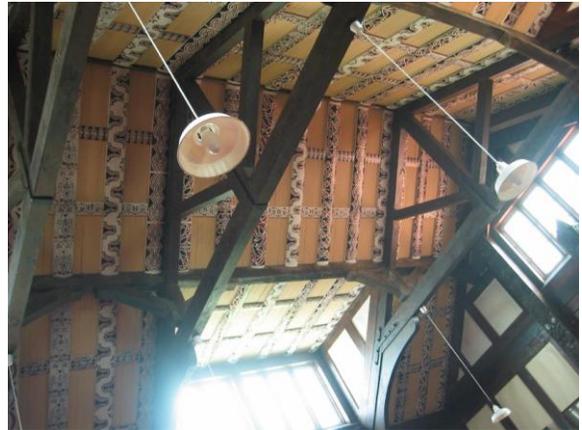
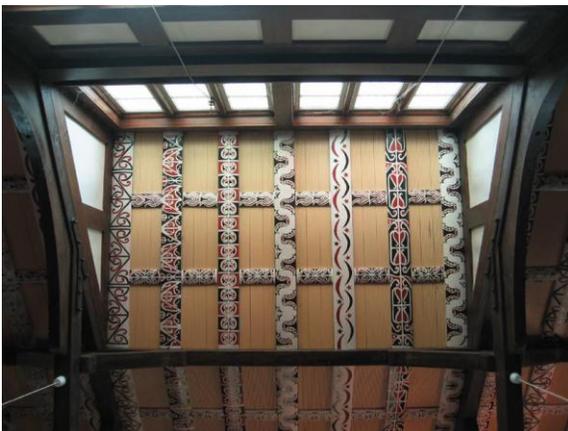
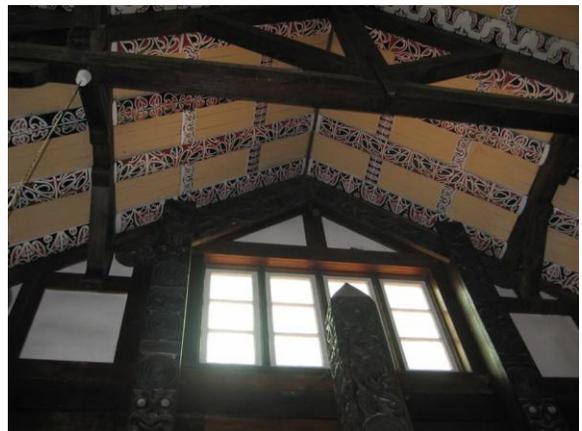
Ceiling & end wall, photos Graeme Burgess.

CONDITION NOTES: Water staining on ceiling north eastern corner. Several windows with broken or cracked glass. Wall panelling “bubbling”

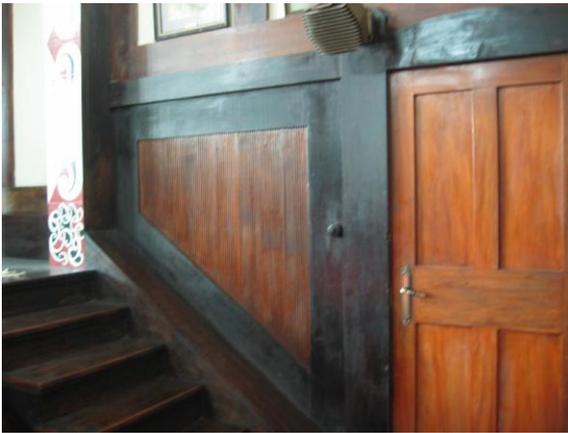
Panelling & steps to the Dias, photo Graeme Burgess.

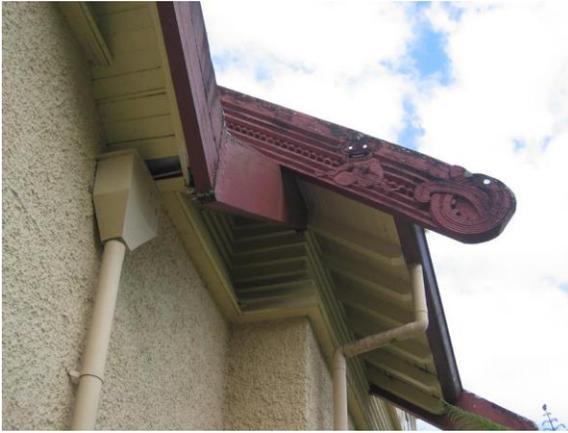
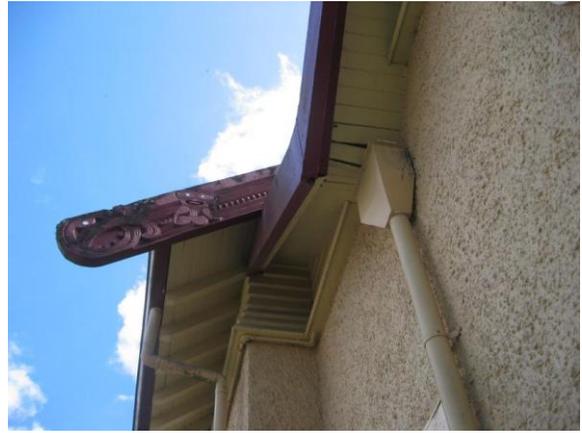
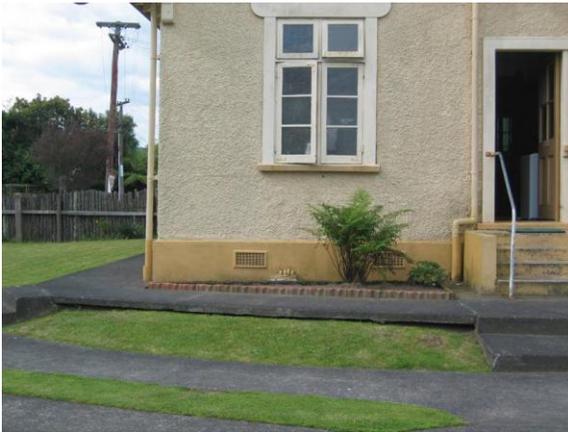
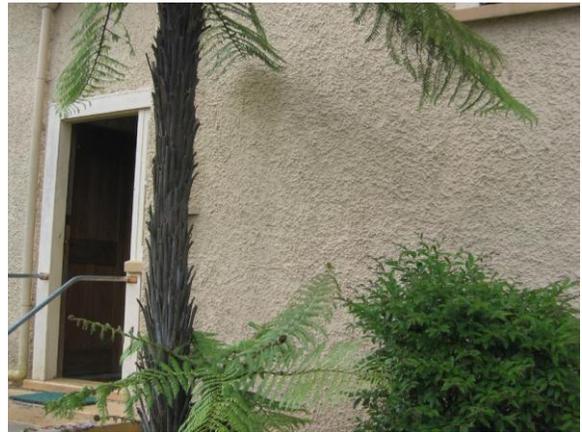
Some cracking in exterior plasterwork, visible at the south end of the western wall, and adjoining the western doorway on the south side of the building.

Above Rainwater outlets, below repaired plaster at South west entry, photos Graeme Burgess.

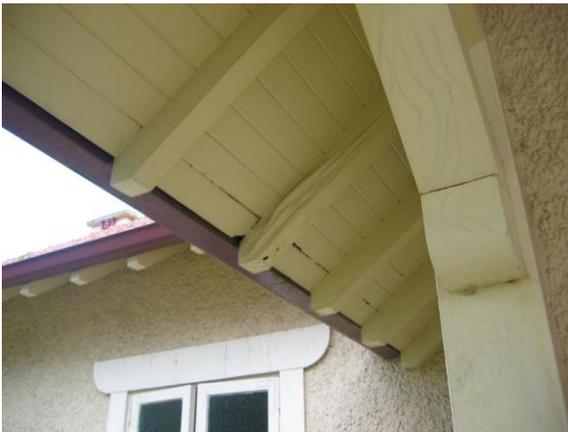
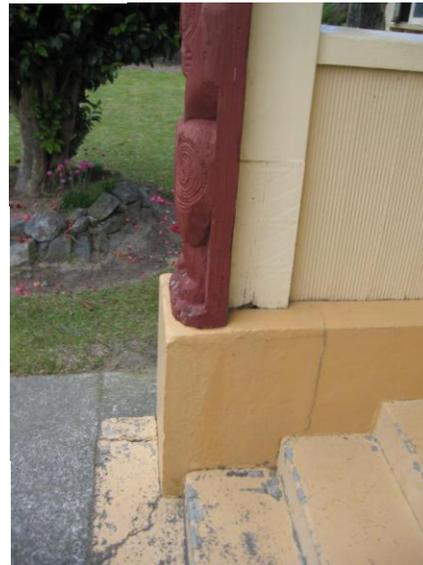
Left, Entry Porch rafters, right entry porch repaired post base, photos Graeme Burgess.

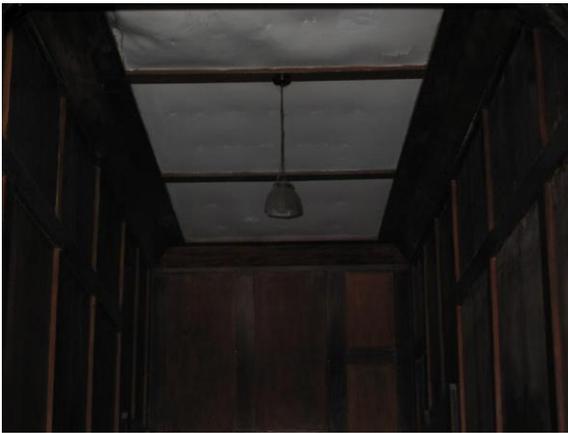
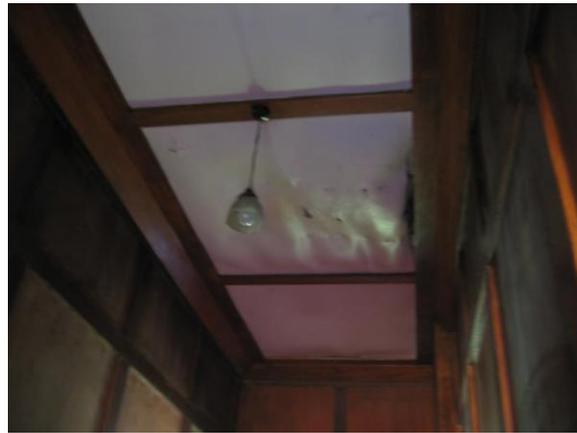
Roof & Flashings: areas of leakage in both side passageways. Leakage over entry lobby.

Warped ceiling panels in passageways, photos Graeme Burgess.

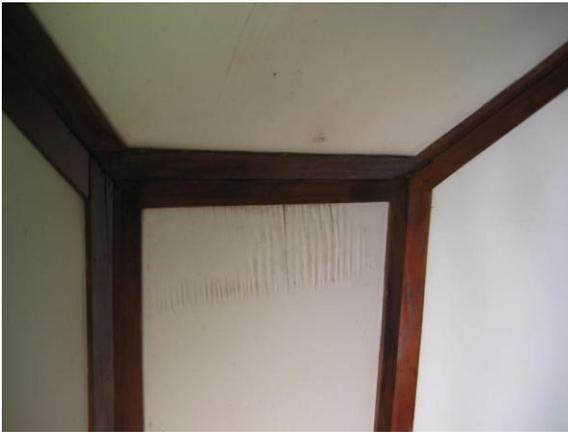
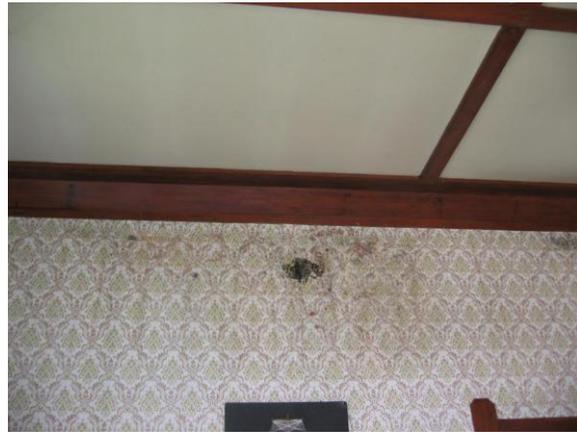
Left, damaged ceiling panels, entry lobby, right deampness in south east Clerk's Room, photos Graeme Burgess.
