McCAHON HOUSE
67 OTITORI BAY ROAD
TITIRANGI

CONSERVATION PLAN
2003

BURGESS AND TREP ARCHITECTS

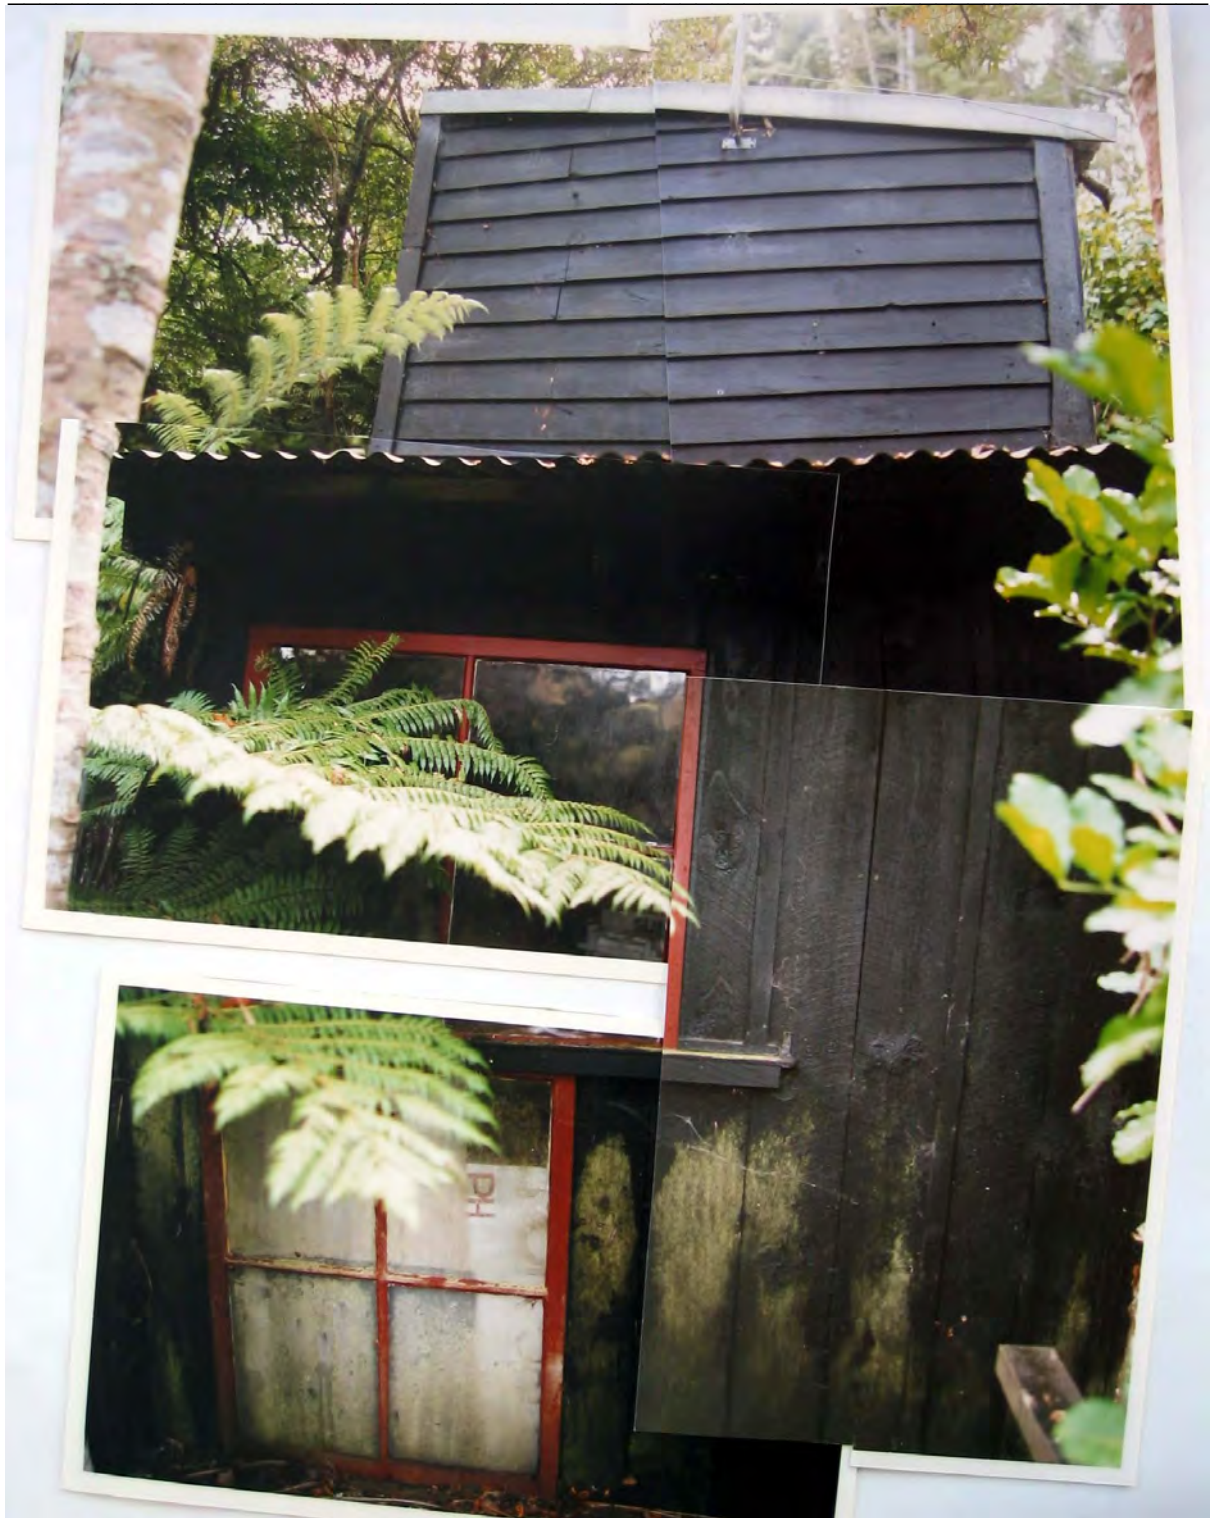
Sleepout under the garage. Photo collage Graeme Burgess 2002

There is a tiki on the door which was fixed there by Jacqueline Amoamo.⁵⁸ The room is not lined. At the outside line of the garage above is a 150x50 post which supports the central bearer of the garage. The joists of the garage run across the room and are also exposed. The room is set back 1.5m under the garage, and 1.3m out beyond it. The projecting section has a lean-to roof framed of rough sawn 140x 50 pine. The floor is of wide timber boards. The clay floor mentioned by McCahon was the bike shed area back under the garage.⁵⁹ There are sections of wide board shelving within the room. In the end wall of the sleep out is an extraordinary glazing arrangement, formed of two demolition sourced double hung window sashes, one set vertically on the floor, the other on its side across it. These were set to run on coloured glass marbles.⁶⁰ The windows no longer function and have lost their marbles. Outside the end of the sleep-out is a deck which was constructed by Jacqueline Amoamo in an attempt to stabilise the garage. Before this was built there was only a narrow ledge/platform barely 300mm wide outside this room.⁶¹ The sub floor of the garage and sleep out, in contrast to the new timber piles of the deck, is redolent of an earlier time. Under the garage the sub floor structure is set on concrete piles. There is a brace between the second and third line of piles. Some of the concrete piles are no longer stable.
