HONE TUWHARE CRIB

1346 KAKA POINT ROAD, KAKA POINT,
SOUTH OTAGO

CONSERVATION PLAN

Prepared for the Hone Tuwhare Charitable Trust

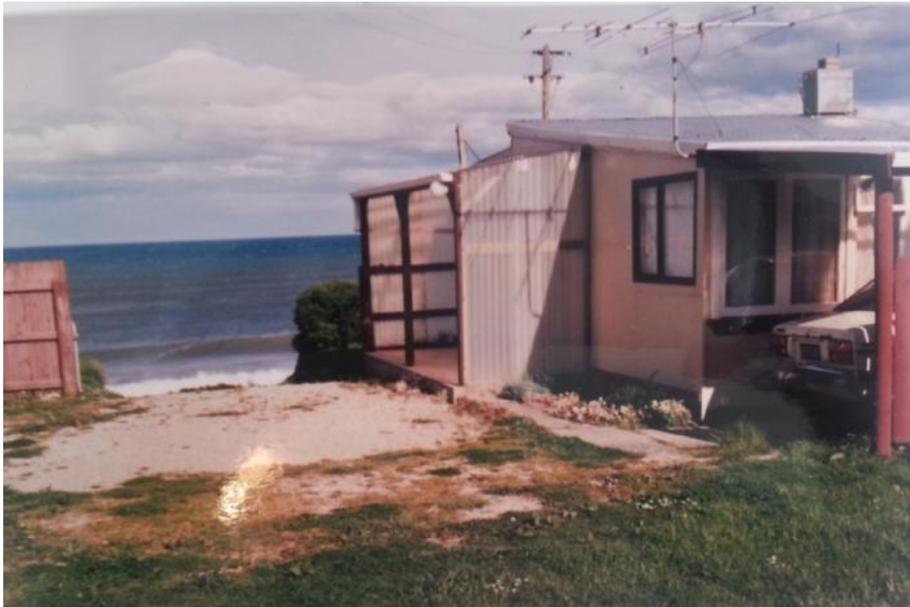
Figure 42. Hone Tuwhare crib with car in carport, Photograph supplied by Rob Tuwhare

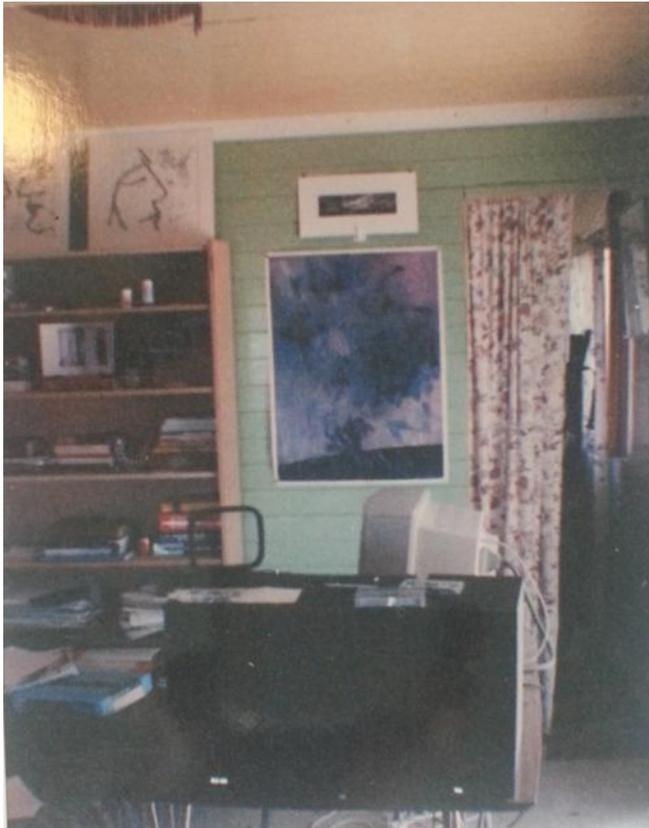
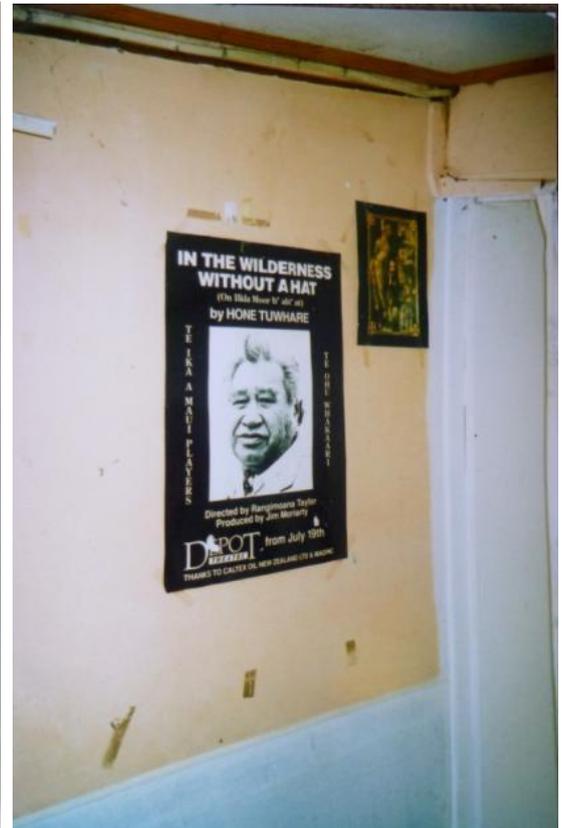
Figure 46. West wall of the living room showing curtained doorway to bedroom (left) Figure 47. Tuwhare poster on bathroom wall (right) Photographs supplied by Rob Tuwhare

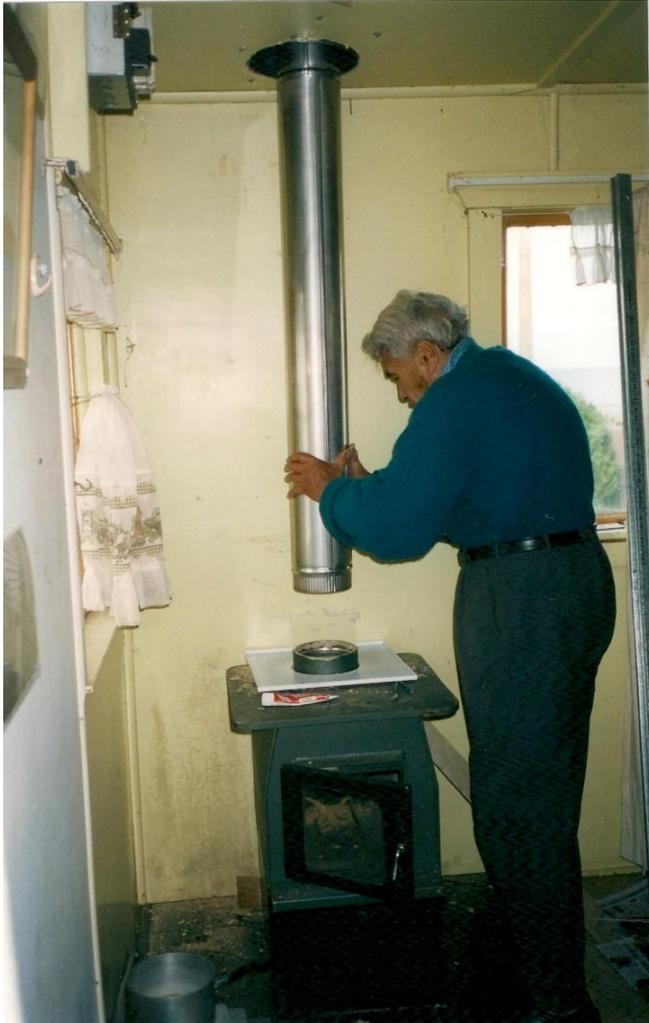
Figure 50. Hone fitting the flue, 2002. Photograph: Jeremy Hay

In 2002 Jeremy helped Hone to install the wood burning fire. The permit for the fire was obtained by Richard Hatherly. The fire was a great success, if slightly worrying for others, as Hone sometimes stacked driftwood against the firebox.⁸¹

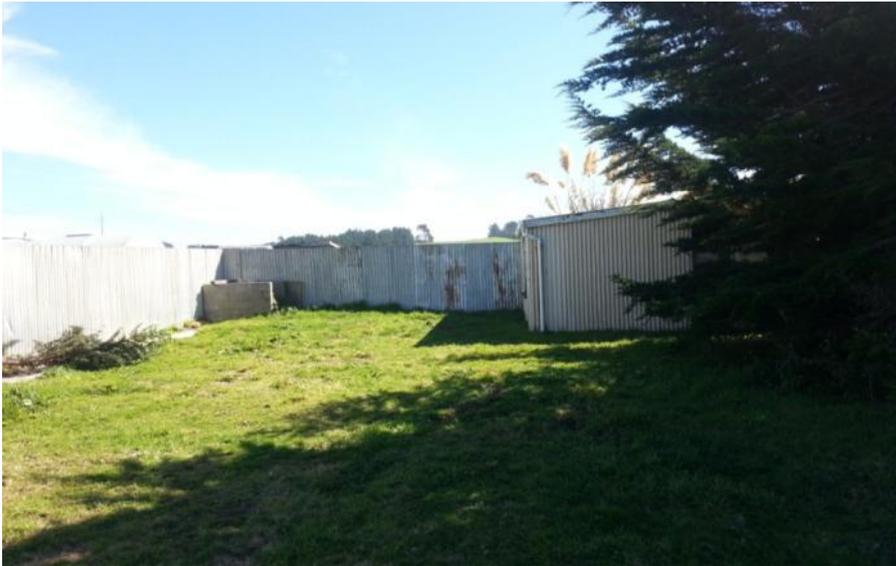
Figure 69. View looking west from the crib over the rear of the property showing the shed, macrocarpa tree (right) and corrugated iron boundary fence, LK March 2014

The waste water system on the property runs to a septic tank that is located to the west of the crib in the rear yard.

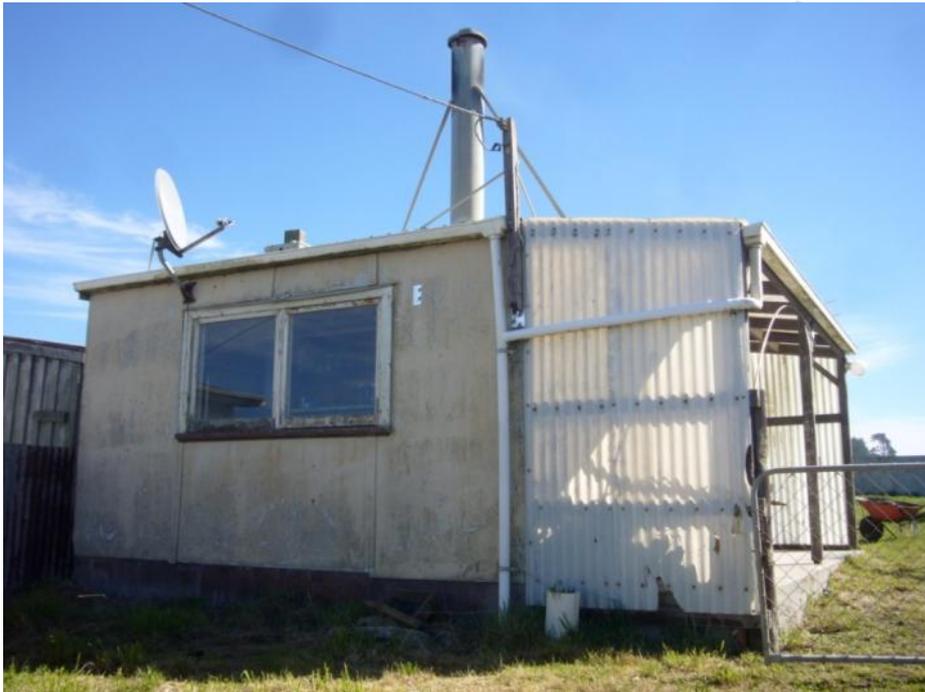
Figure 73. East Elevation of the crib, LK March 2014

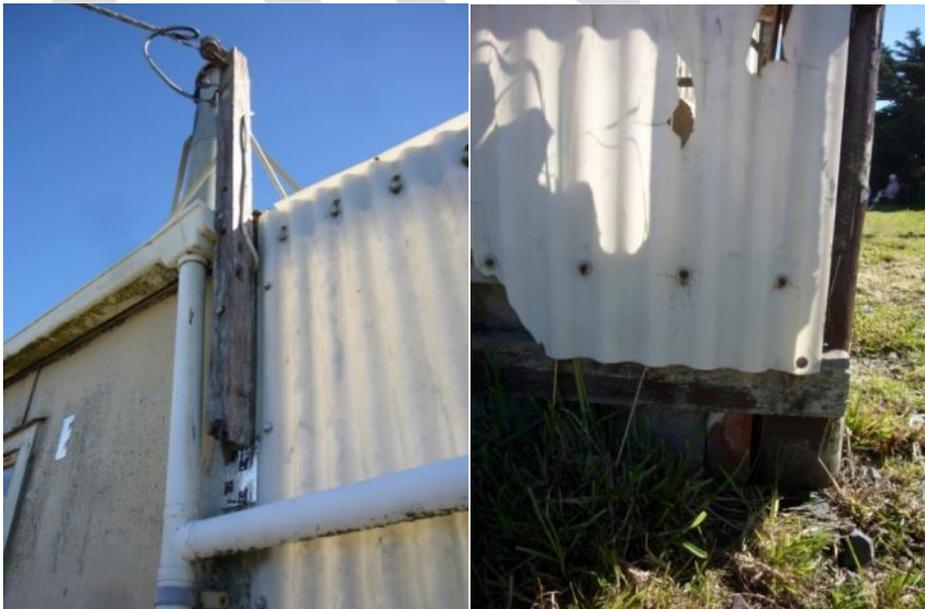
Figure 74. Power line detail (left) Terrace edge (right), LK March 2014

The power feed runs down the side of the batten and then is drilled through the north eastern corner of the crib. Behind the power connection, and slightly back, is the metal flue of the wood burner. This is a plain round metal flue. Angle iron braces are fitted from the flue to the roof. The power batten has round section metal brace elements also fitted to the roof.

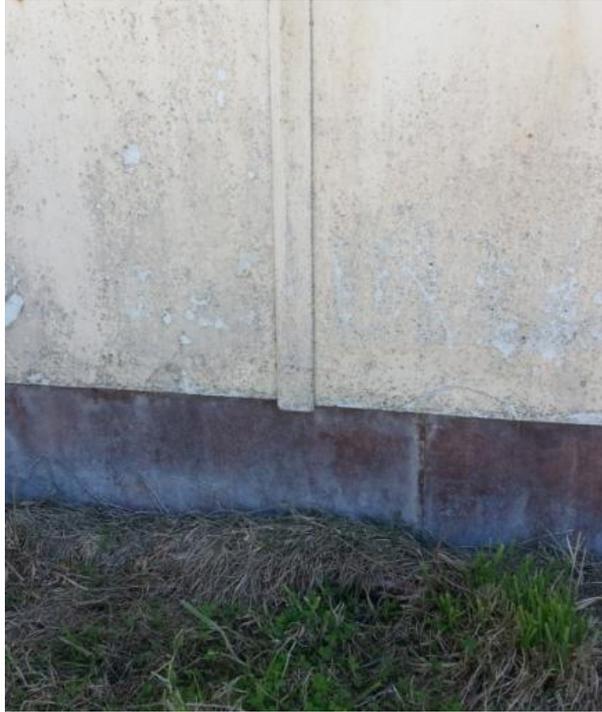
Figure 75. Old downpipe connection (left) Figure 76. Sheet connection detail (right),) LK March 2014

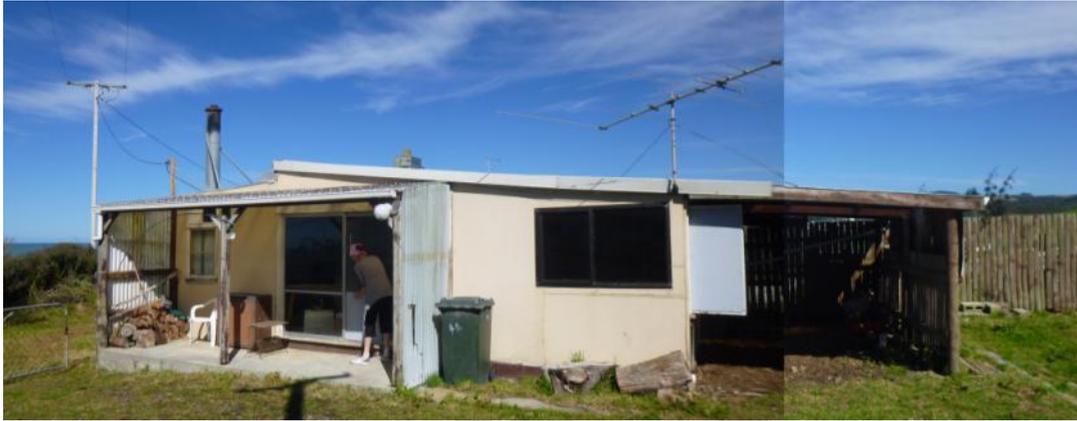
Figure 80. North Elevation of the crib, LK March 2014

The north face of the crib is the main frontage. The form of the building is most clear on this side of the crib. The eastern end containing the kitchen has its own lean-to roof sloping down from the end wall of the living area to the outside. This roof has no barge and no barge flashing. The wall steps up at that junction and from there the main roof of the crib slopes back to the west. Along this section of the roof there is a full barge flashing. The pitch of the roof is shallow, and becomes even more shallow at the intersection with the bedroom. The roof extends at this same pitch over the carport at the west end of the crib. The open carport is in line with the face of the crib on this frontage. There is no barge flashing on the carport roof.

A simple lean-to verandah/porch has been built along the northern side of the crib from the north east corner through to the west wall of the living area. The end panels and roof are clad in clear corrugated plastic. The front edge of the porch roof is finished in a PVC spouting with a rainwater head at the eastern end and an outlet that wraps back to the downpipe on the eastern frontage. At the eastern end the roof is set in line with the top edge of the front fascia. At the western end the roofing fits just beneath the barge board. There is no apron flashing and no barge flashings on the porch roof. The roof of the porch is framed in plain exposed 100 x 50 framing. There are seven rafters set out at even centres, with a centre line of dwangs.

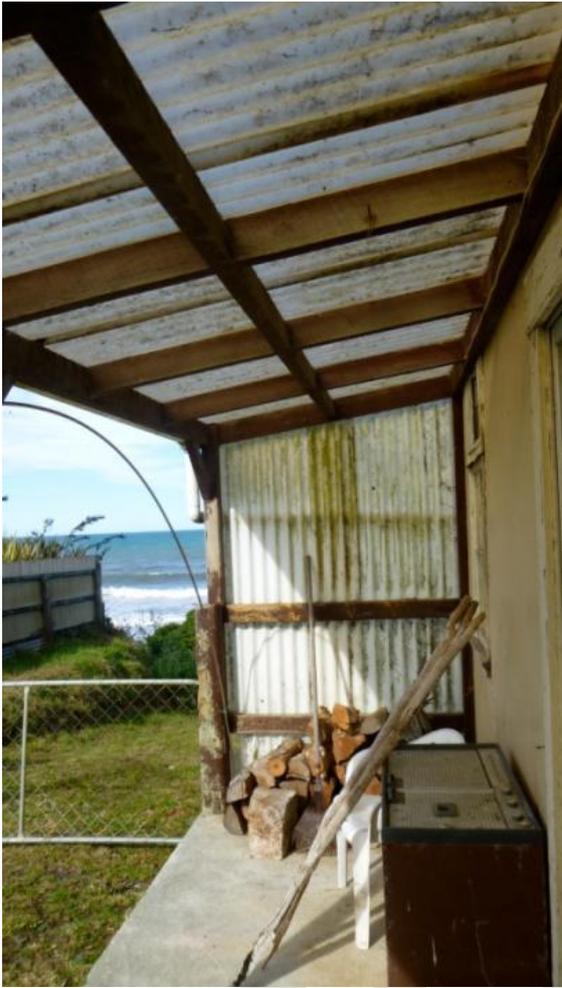
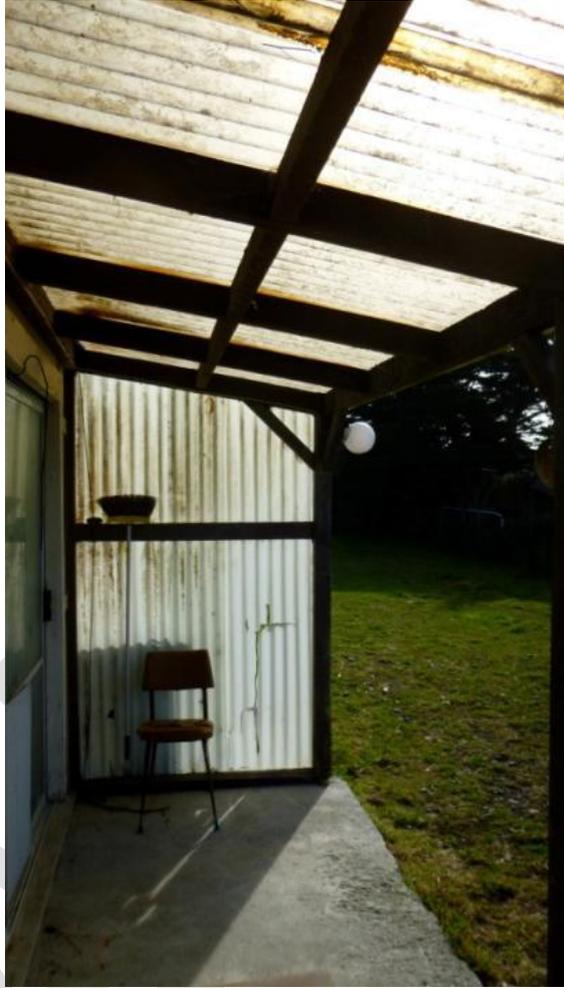
Figure 83. East interior porch wall (left) Figure 84. West interior porch wall (right) GB March 2014

At the wall of the crib the rafters are supported on a planted stringer, also 100 x 50, and a 100 x 50 lintel in the plane of the rafters spans across the outside line. The lintel beam is supported by framing at each end and by a 100 x 100 post at the centre. At the top of the post there are two 100 x 50 angle brackets, in line with the face of the lintel, and there are matching planted brackets at each side. The post at the eastern end is fitted to the top of the fence post, which is offset to allow for the projecting horizontal rails, with vertical solid blocking between. From the base of the fence post a narrow polyethylene pipe arcs up across the porch and is fixed to the top of the central post. At the western end of the porch a single globe light on a timber block has been fitted to the end framing. The central post is supported on a proprietary galvanised bracket set into the porch deck. The deck is poured concrete. At the eastern end it is approximately 300 above the ground, at the western end it is almost at ground level.

On the wall of the crib within the porch there is a window at the east end. This is a fixed timber sash with a single horizontal glazing bar. A framed panel has been fitted above the window up to the stringer line of the porch roof. The meter board is at the right hand side of this panel. The window has been blocked on the inside by the fire rated panelling behind the solid wood burner. An aluminium "ranch slider" door has been fitted at the right hand side of the porch. This is a 1970s period door. It is plain anodised and has very slim profiles. The right hand section slides across the left hand panel, which is fixed. The door is set 70mm above the porch deck.

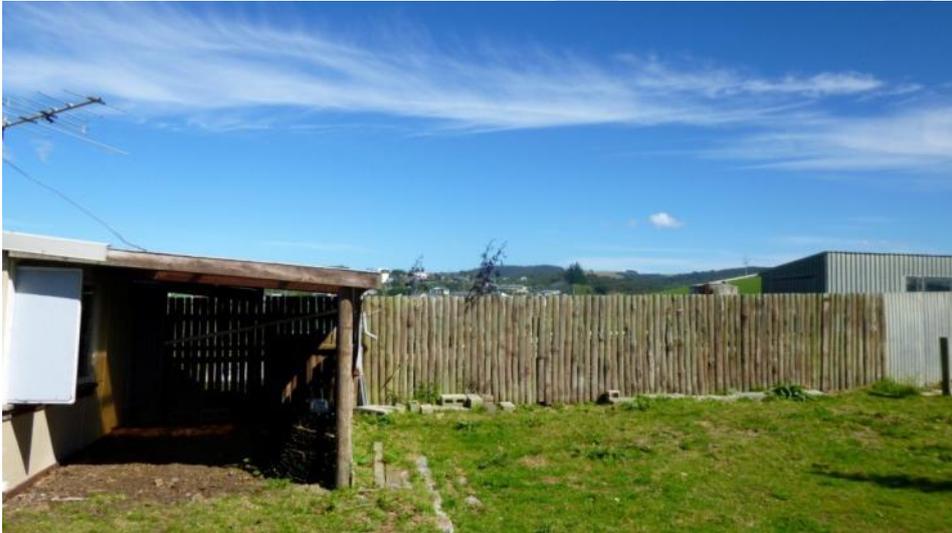
Figure 85. North elevation of lean to carport showing south boundary fence GB March 2014

The pvc spouting fixed to the fascia runs to a rainwater head at the south corner. The downpipe drops from this point and bends back through to the face of the fence on the boundary inside the carport. There is a remnant section of galvanised iron downpipe hanging loosely from the outside of the wall at the south corner. The base of the outside wall of the carport is a plain hit and miss board fence, on two horizontal rails. Above the fence sheets of vertical corrugated iron are fitted at the edge of the purlin and down over the face of the fence to the top rail line. The vertical corrugated sheeting is fitted along most of the wall but not at the southern end.

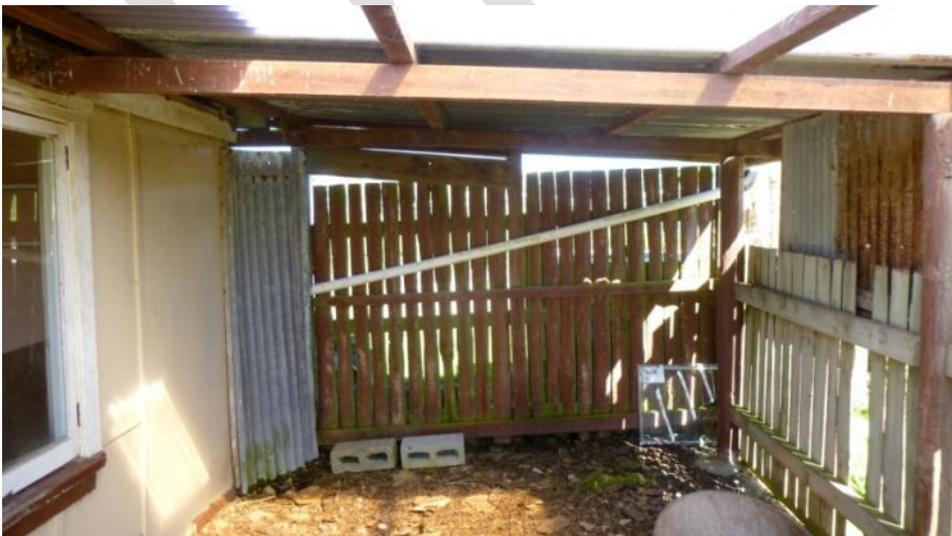
Figure 86. South wall of lean to carport GB March 2014

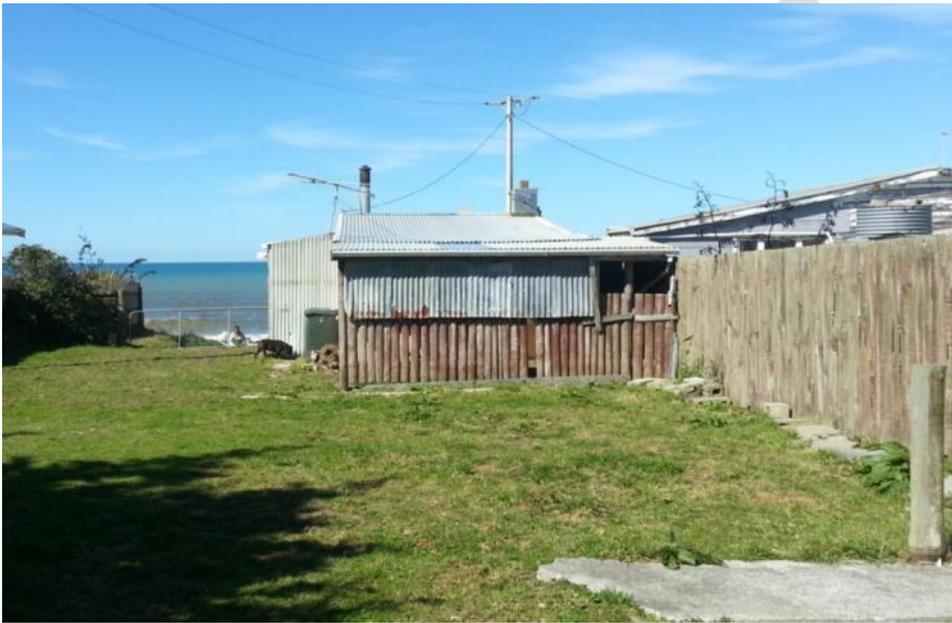
Figure 88. West Elevation of the crib/ lean to carport, LK March 2014

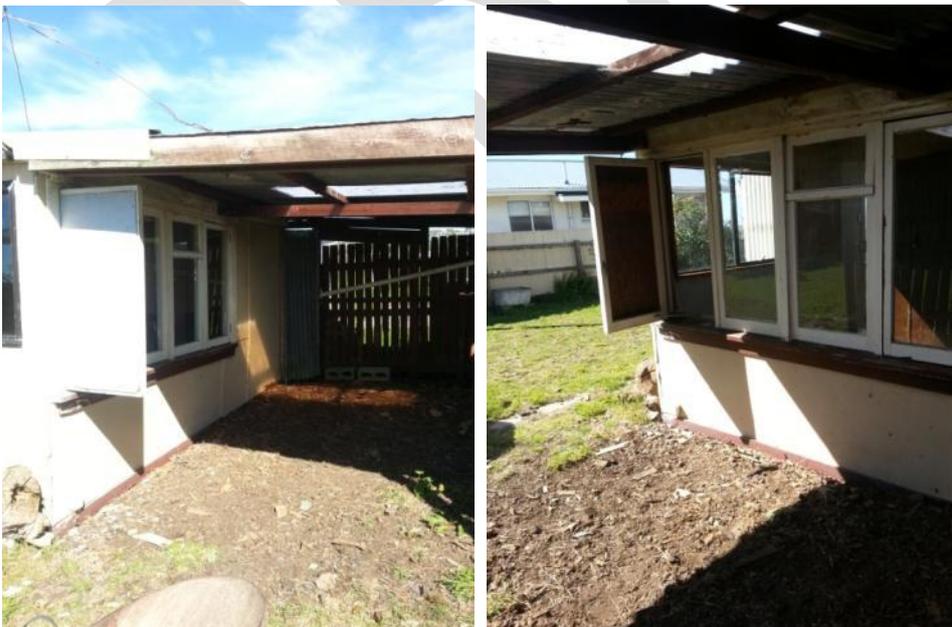
Figure 89. West wall of crib, showing bedroom windows, GB March 2014

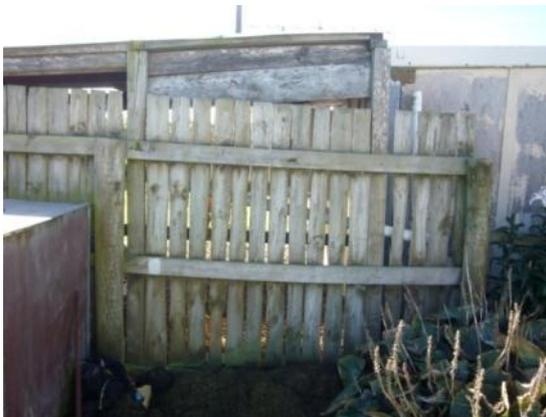
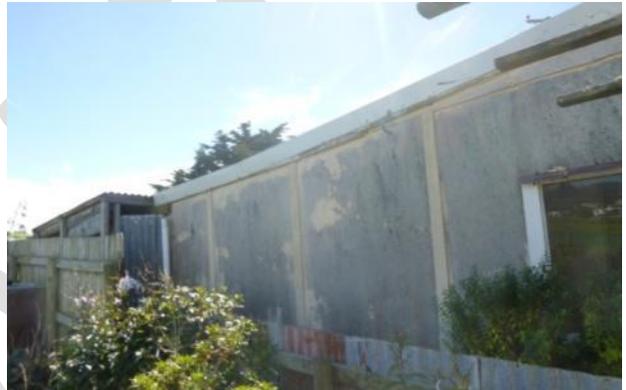
Figure 91. South wall of lean to carport (left) Figure 92. South wall of crib. view from neighbouring property looking west (right) GB March 2014

At the western end the rafter of the carport runs through on the face of the cladding. Beneath the rafter a vertical sheet of corrugated iron has been fixed across to close the opening between the face of the crib and the end of the carport which finishes into the boundary fence. The fence changes at this point from vertical corrugated iron on a plain timber frame to a hit and miss vertical board (1/4 rounds) fence through the carport. The corrugated iron fence is 1200mm high, the timber fence is over 1800mm.

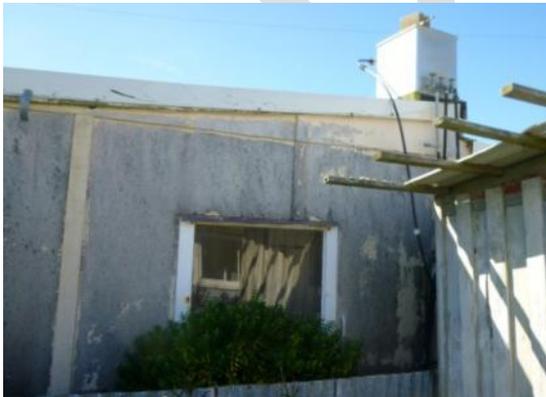
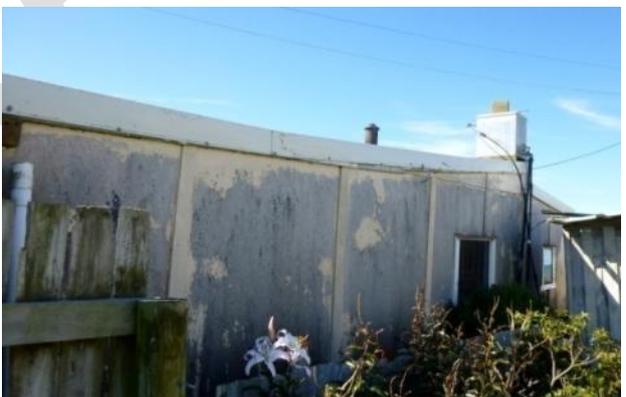
Figure 93. South wall of crib, showing bathroom window as viewed from neighbouring property neighbours shed pictured right (left) Figure 94. South wall of crib view east. (right) GB March 2014

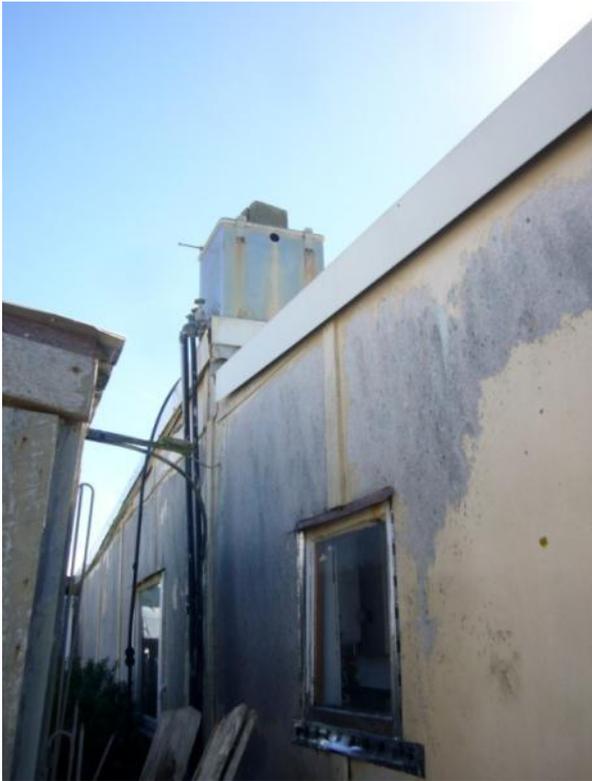
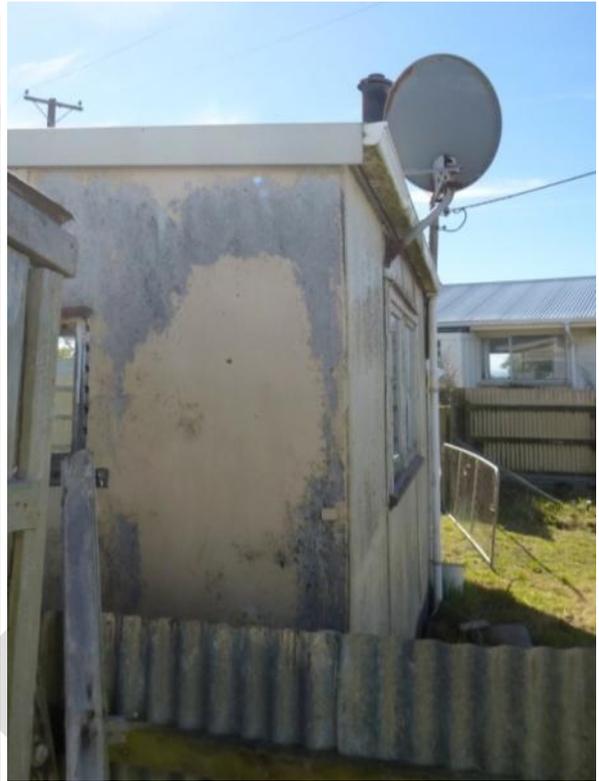
Figure 95. South wall for crib, showing bathroom and kitchen windows, and proximity of neighbouring shed (left) Figure 96. South east corner of crib as viewed from neighbouring property (right), GB March 2014

Close to the south east corner the earth rod for the house is driven into the ground and wired to the house.

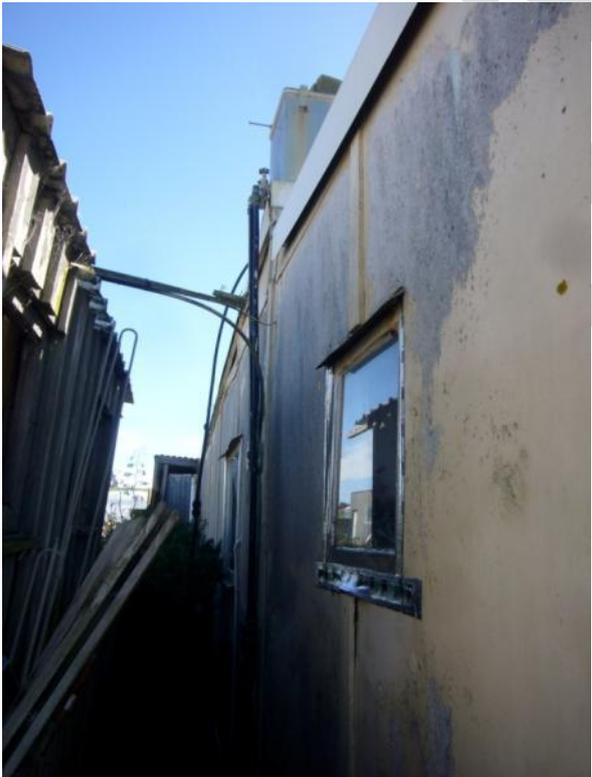
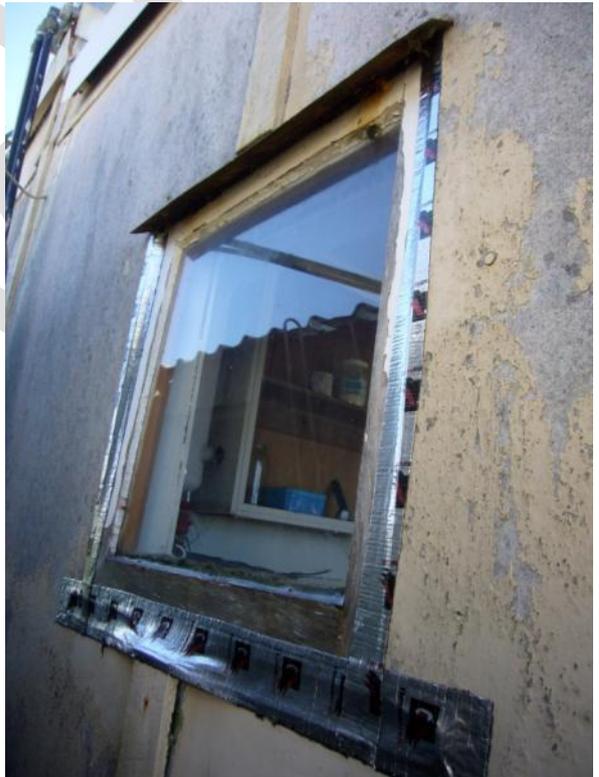
Figure 97. South wall, view west, showing pipes between crib and neighbouring shed (left) Figure 98. Kitchen window detail, showing temporary weathering repairs (right), GB March 2014

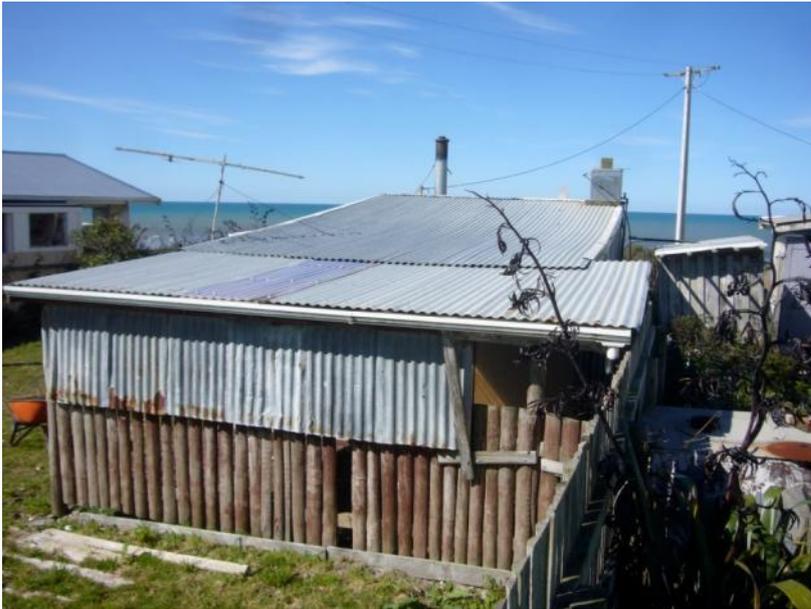
Figure 98. View east over roof of the crib and carport lean to, GB March 2014

There is a separate roof over the kitchen area, a plain lean-to type roof at a lower level falling to the seaward end of the building. This roof is also shallow pitched. The cylindrical flue of the fire penetrates through the north eastern corner of the kitchen roof. The flue is braced back to the roof with two sections of galvanised angle iron. The power connection, at the outside face on line with the northern wall, projects above the roof line and is also braced back to the roof with metal tie rods. The kitchen roof has no barge or barge flashing. The main roof does have a planted barge with a full over-flashing. At the intersection between the two roofs the cladding runs straight into the edge of the apron flashing, with no additional weathering.

The spouting across the eastern frontage and across the face of the porch connects to a downpipe at the north eastern face of the eastern frontage. The rear spouting, across the western face of the carport, connects to a downpipe that is run back to a connection with the old storm water line at the south west corner of the crib.

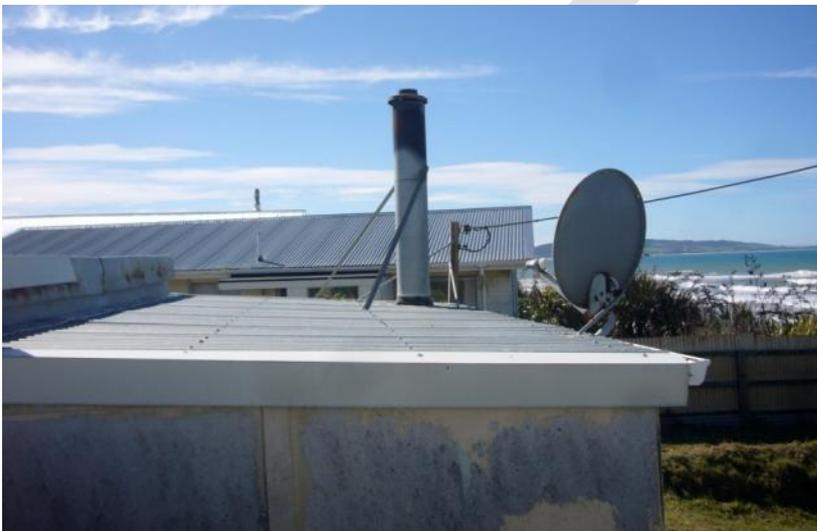
Figure 99. View north over lean to kitchen roof, GB March 2014

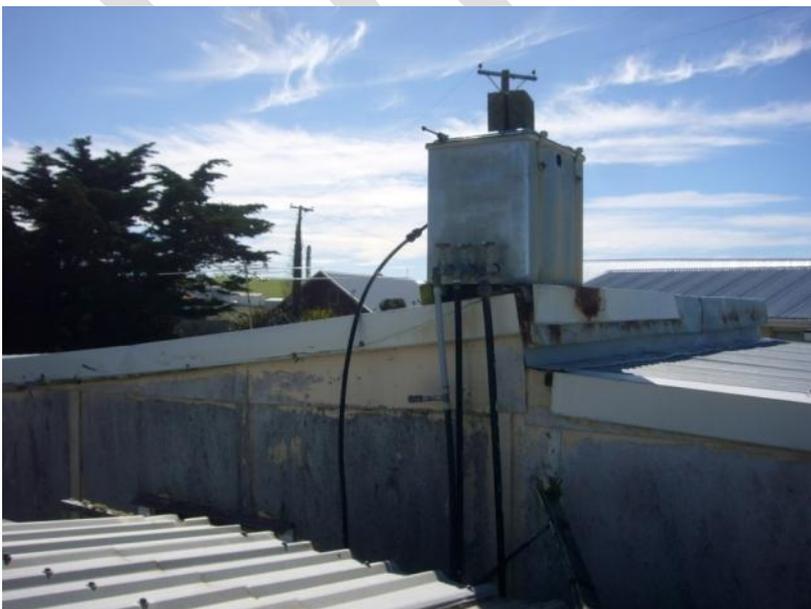
Figure 100. View north showing roofing junctions, GB March 2014

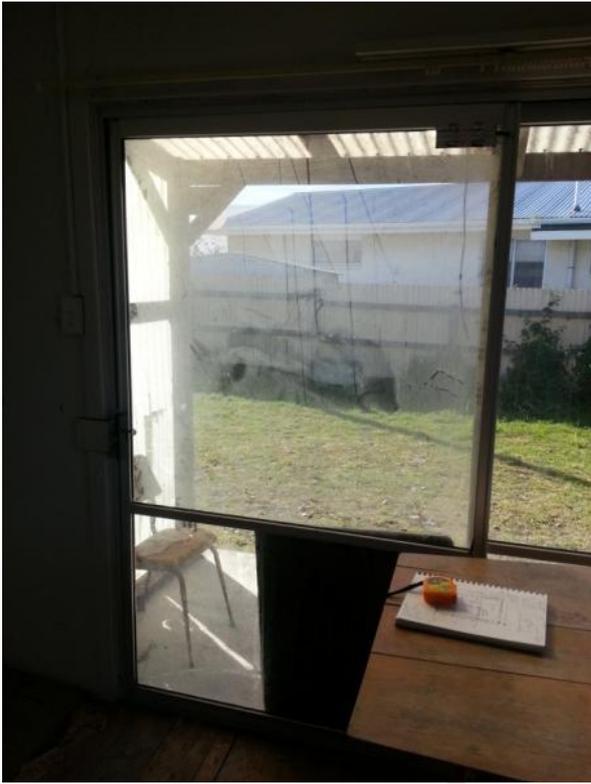
Figure 102. North wall of living area showing ranch sliders and table, GB March 2014

The linings in the living area are t g + v horizontal boards (match lining) on the walls and across the ceiling (north/south), (except at the face of the lintel to the kitchen area, which has been lined in oil tempered hardboard, with “D” mouldings to the junctions). At the eastern end of the room there is a metal panel fitted to the ceiling, which may once have been a flue position. Close to this a bamboo rod on metal block and tackles, has been fitted to the ceiling as an interior washing line.

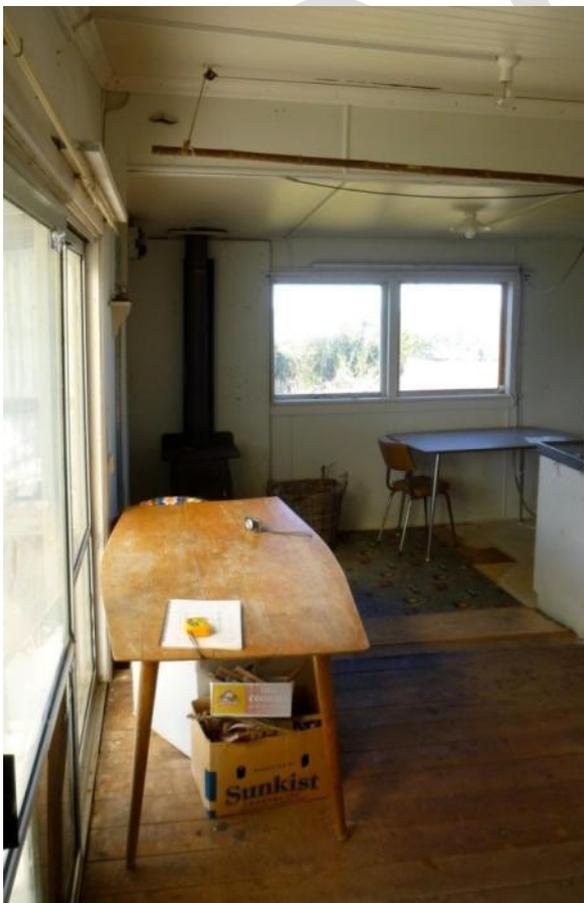
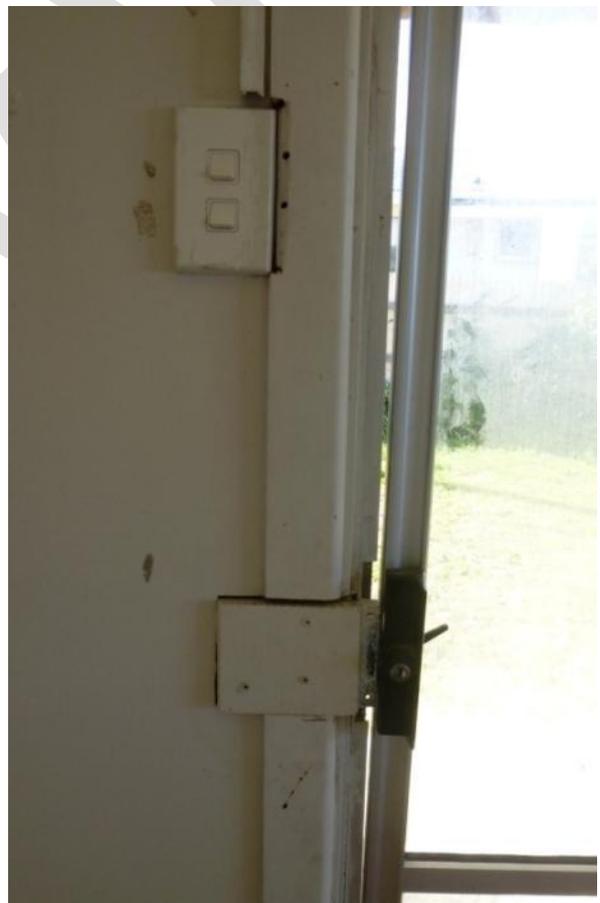
Figure 106. View through living area into kitchen from bedroom (left) Figure 107. Ranch slider door detail (right) GB March 2014

The fixing holes in the cornice are not filled. The floor in this area is t + g timber running across the room (north / south). An aluminium “ranch slider” has been fitted in the external wall, the north wall. This is the only entry to the crib. The substructure has slumped at the line of the bedroom wall.

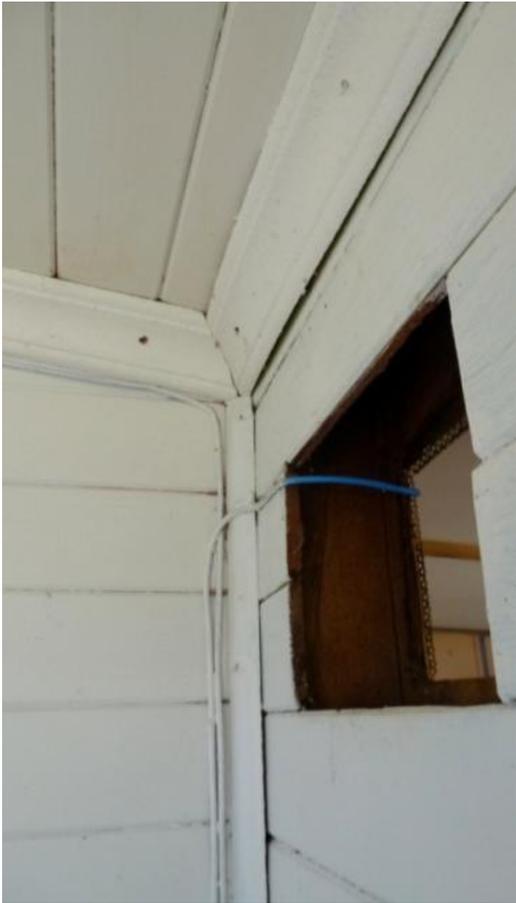
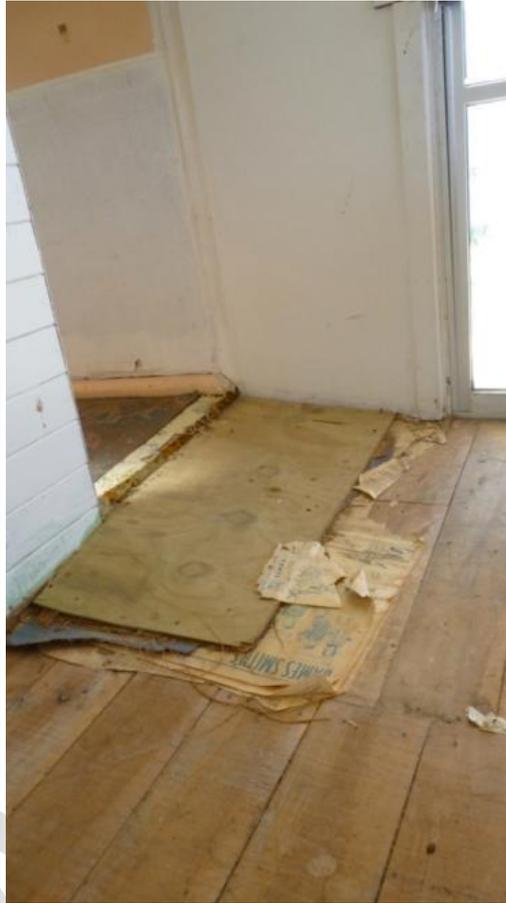
Figure 108. South west corner, ceiling in living area showing opening (left) Figure 109. Plywood ramp into bedroom from living area, north west corner (right) GB March 2014

The doorway to the bedroom is at the north west corner of this room, on the west wall. There is no door, only a surface mounted curtain track. The bedroom is slightly higher than the living area and a crude ramp of plywood fixed over sections of carpet, linoleum and old newspapers has been constructed at this threshold. The doorway slumps badly to the left and the wall lining has opened where the structure has failed. At the south end of this wall (the western wall of the room) a small rectangular opening has been cut at the top of the wall into the bedroom. The opening is not finished in any way on this side.

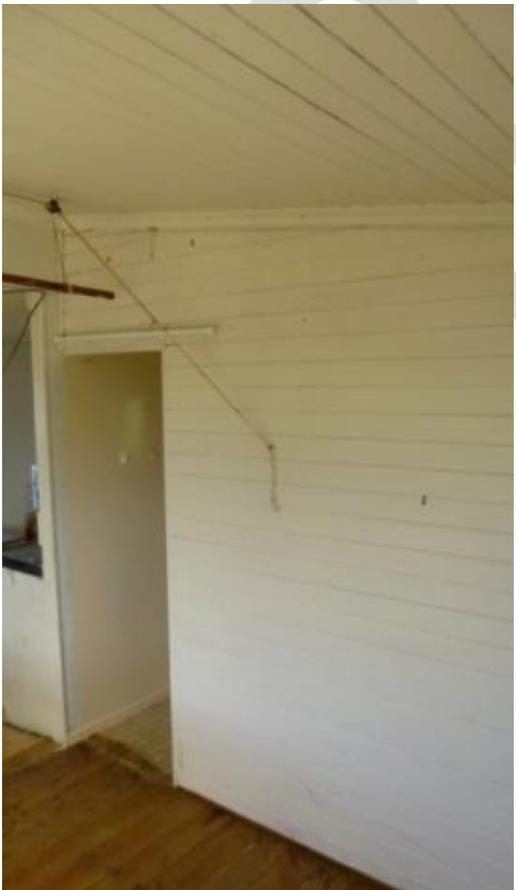
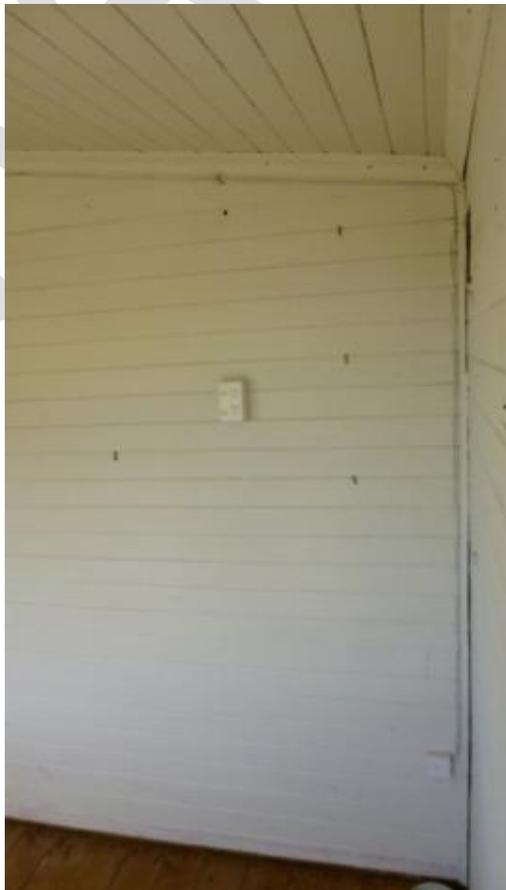
Figure 110. South wall of living area showing doorway through to bathroom, GB March 2014

The doorway into the bathroom is at the south east corner of the room on the central wall. There is no door, only a curtain track, mounted above the doorway on the wall of the living area. The kitchen wall projects out slightly at this corner, and the hardboard wall finishes of the kitchen return back from the corner, through the doorway and into the bathroom. The living area wall butts into a plain door jamb.

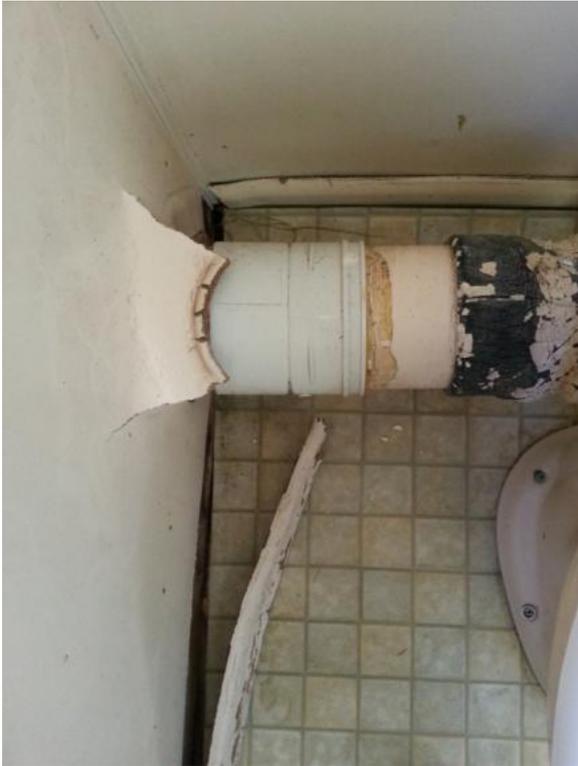
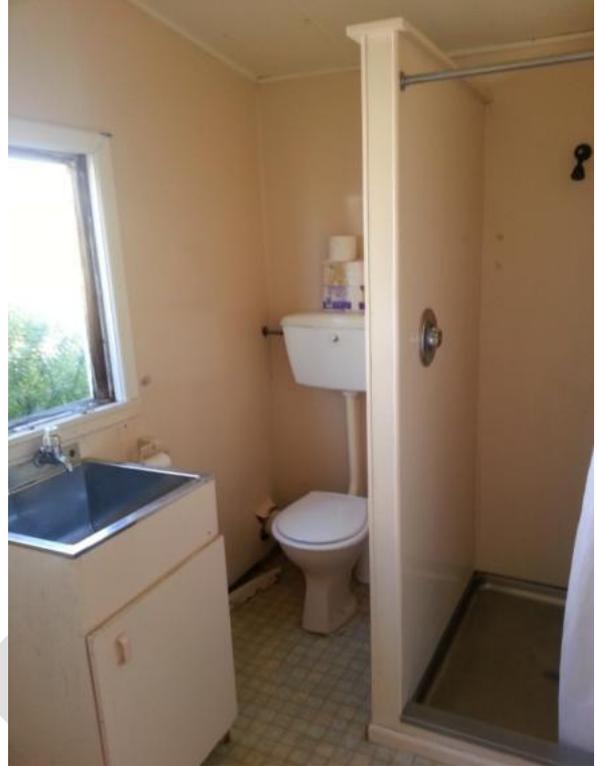
Figure 112. Pipe from WC & peeling skirting board (left) Figure 113. Bathroom south west corner (right) LK March 2014

The toilet is at the south west corner, on the west wall. This is a ceramic pan and plastic cistern. The pan has a side outlet that has been crudely forced through the wall. The toilet is pale pink, matching the wall colour.

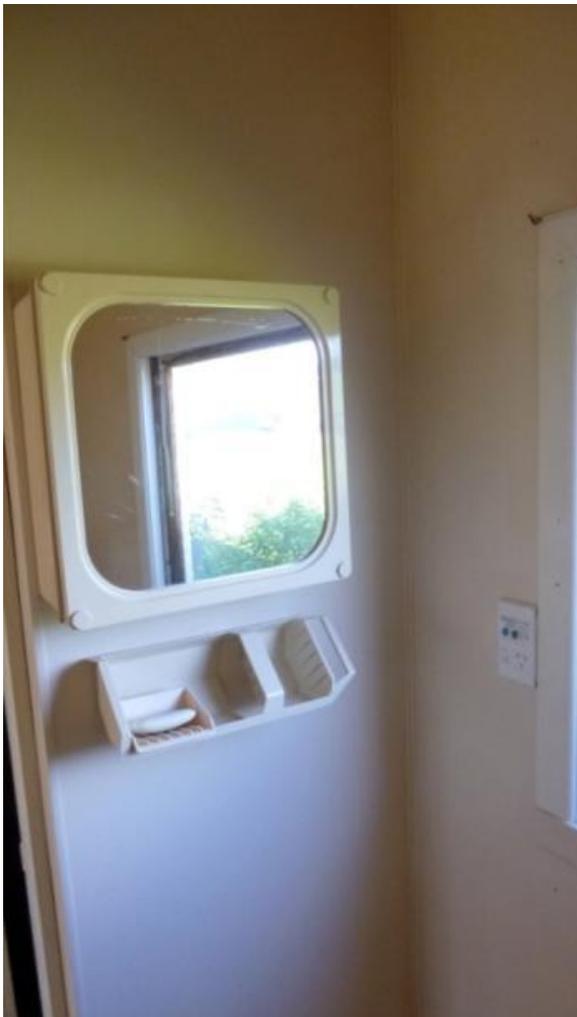
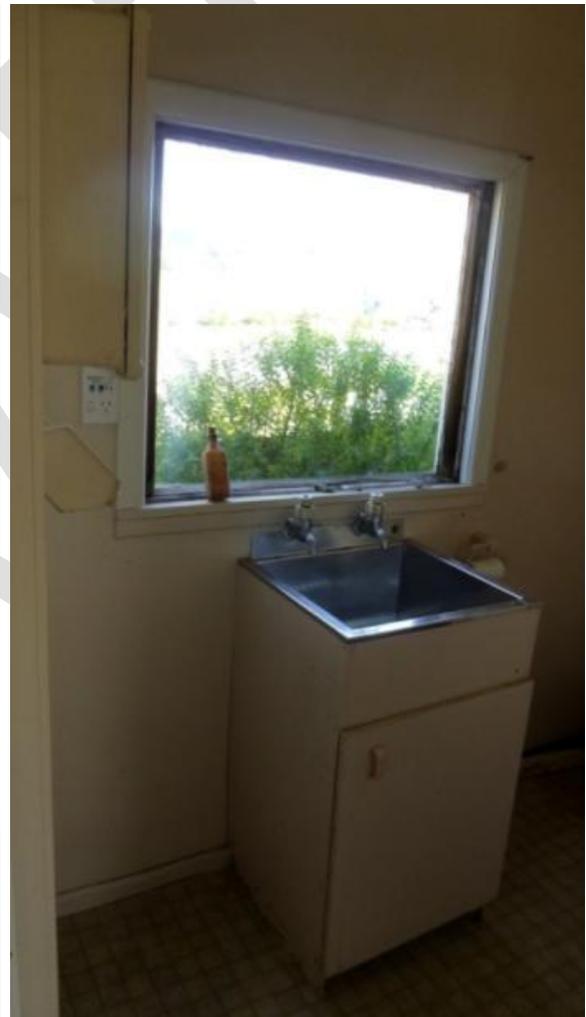
Figure 112. Mirror on HWC cupboard wall (left) Figure 113. South wall showing window and tub (right) LK March 2014

There is a rectangular window on the outside (south) wall of the bathroom just above a tub basin on an enamel painted customwood cupboard unit. The window has an awning stay. The opening is “picture framed” with plain 60 x 12 mm bullnose mouldings.

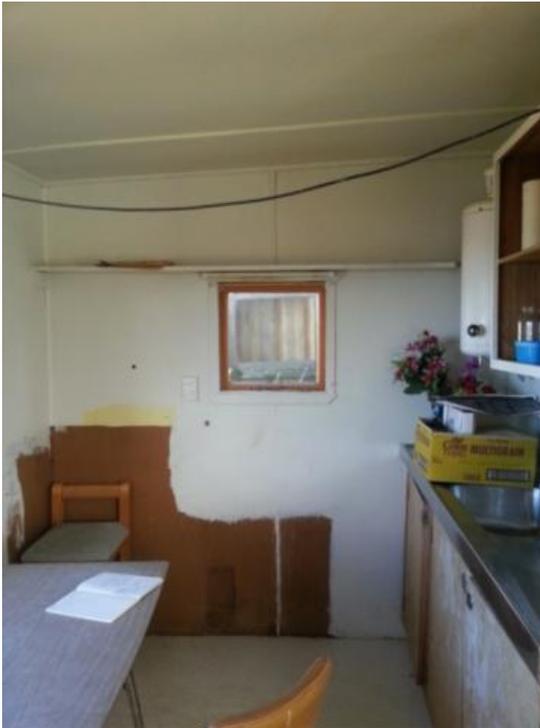
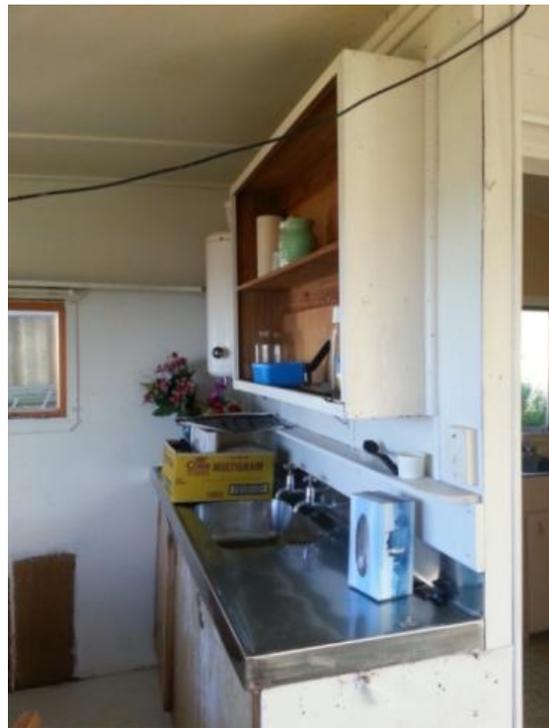
Figure 113. South wall of the kitchen area showing table (left) Figure 114. South west corner showing kitchen cabinetry (right) LK March 2014

The kitchen bench is set against the bathroom wall. This comprises a stainless steel bench-top with a central sink, set on a Rimu and plywood cupboard unit. There is a wall mounted cupboard unit above this, and a boiler unit on the wall to the left.

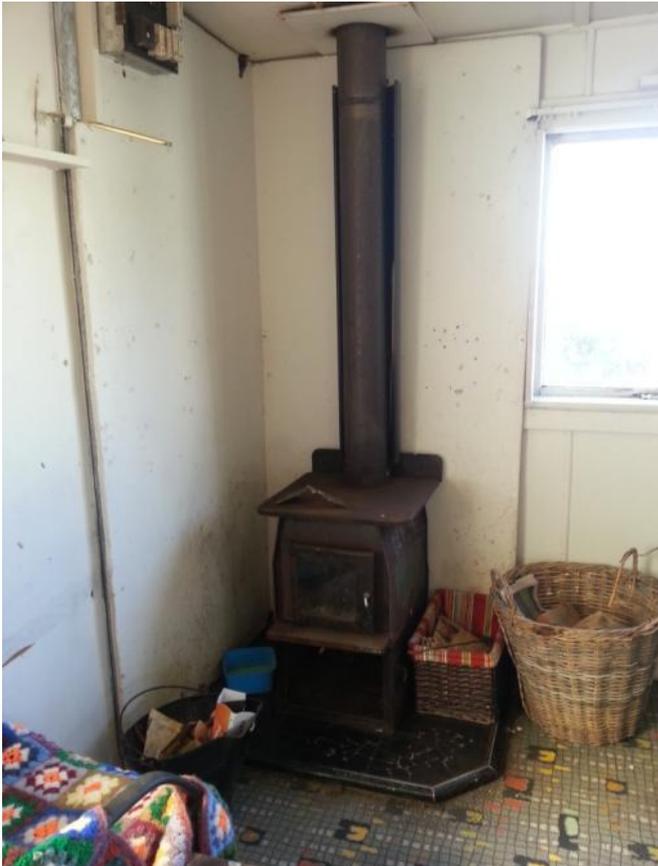
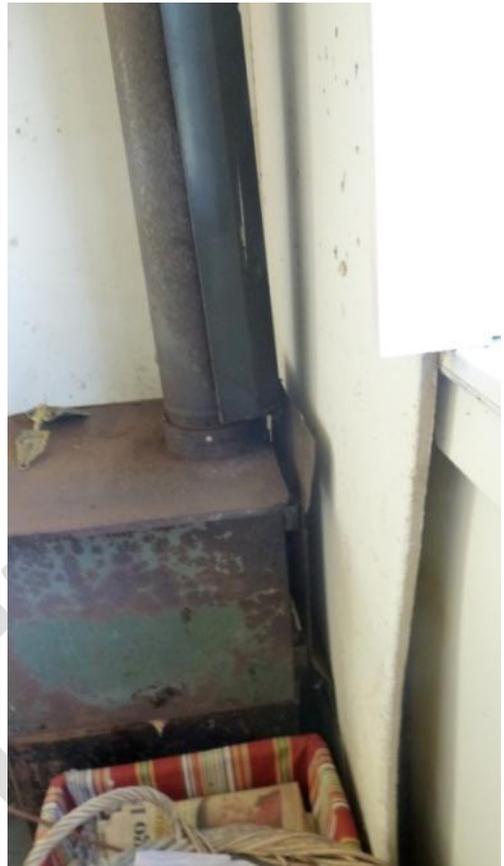
Figure 119. North east corner of kitchen area showing wood burner (left) Figure 120. Wood burner detail (right) LK March 14
