HONE TUWHARE CRIB

1346 KAKA POINT ROAD, KAKA POINT,
SOUTH OTAGO

CONSERVATION PLAN

Prepared for the Hone Tuwhare Charitable Trust

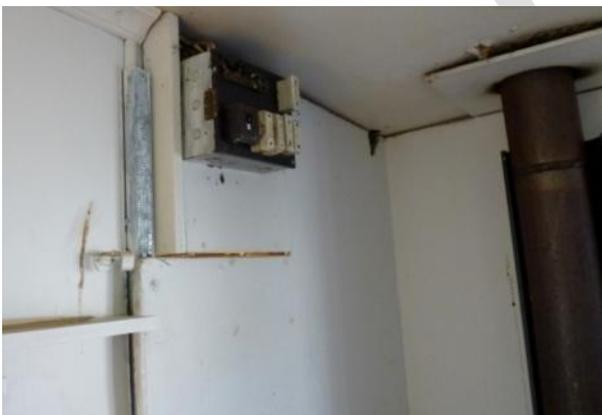
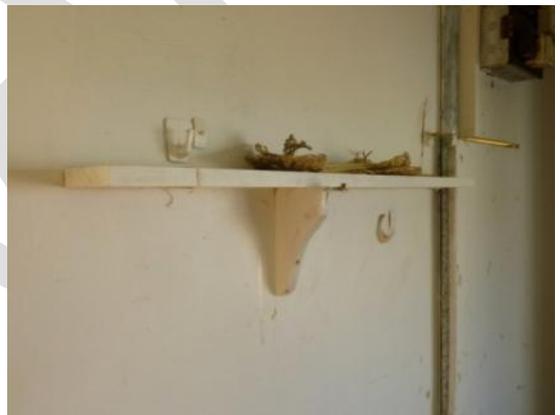
Figure 121. North east corner of kitchen area showing electrical switch board and flue from wood burner (left) Figure 122 Shelf on north wall (right) LK March 2014

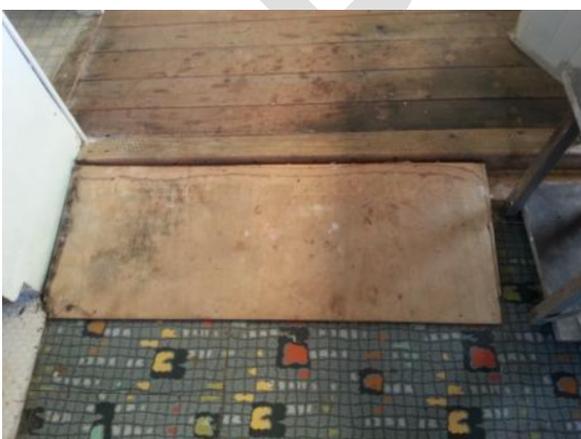
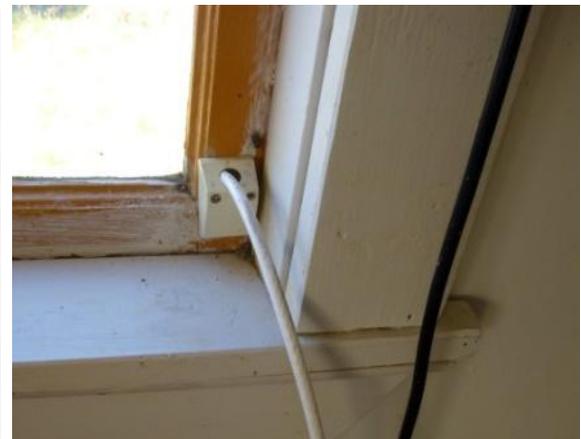
Figure 123. Linoleum patchwork on kitchen floor (left) Figure 124. Electrical socket detail below window on east wall (right) LK March 2014

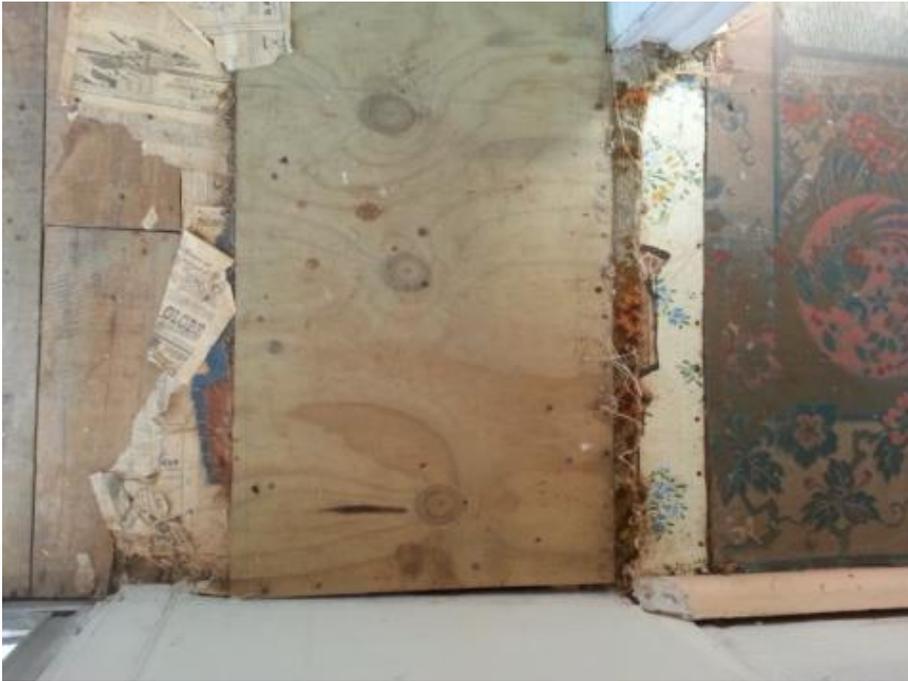
Figure 138. Ramp into bedroom, GB March 2014

The doorway to the bedroom is at the north west corner of this room, on the west wall. There is no door, only a surface mounted curtain track. The bedroom is slightly higher than the living area and a crude ramp of plywood fixed over sections of carpet, linoleum and old newspapers has been constructed at this threshold. The doorway slumps badly to the left and the wall lining has opened where the structure has failed. At the south end of this wall (the western wall of the room) a small rectangular opening has been cut at the top of the wall into the bedroom. The opening is not finished in any way on this side.

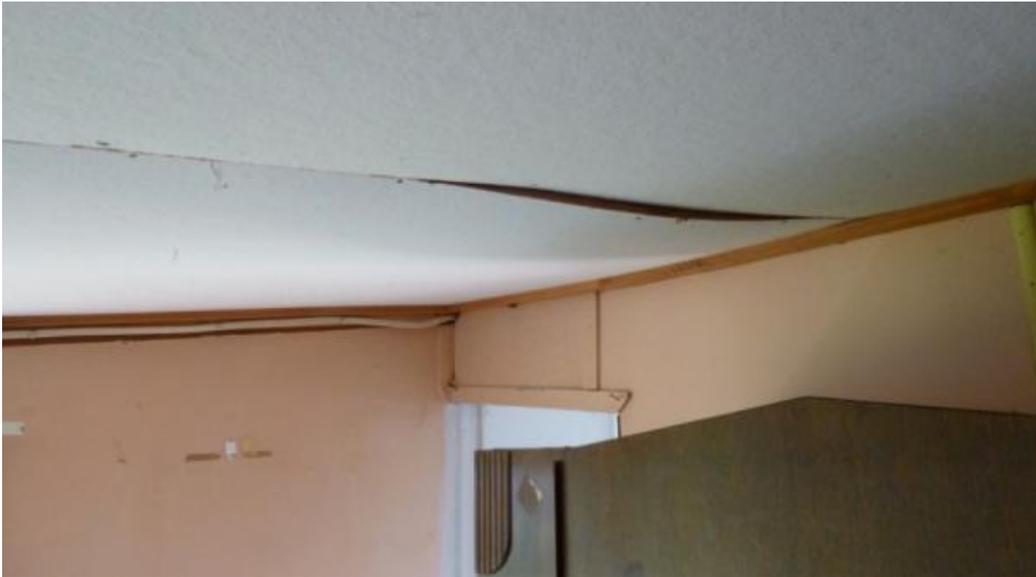
Figure 141. Ceiling in bedroom, GB March 2014

The ceiling within this space is “pinex softboard”. Only some of the ceiling junctions are covered with 60 x 18 rectangular mouldings. A similar timber batten has been fitted to the ceiling to hold the light fitting. This is a plain batten holder with a “Chinese hat”.

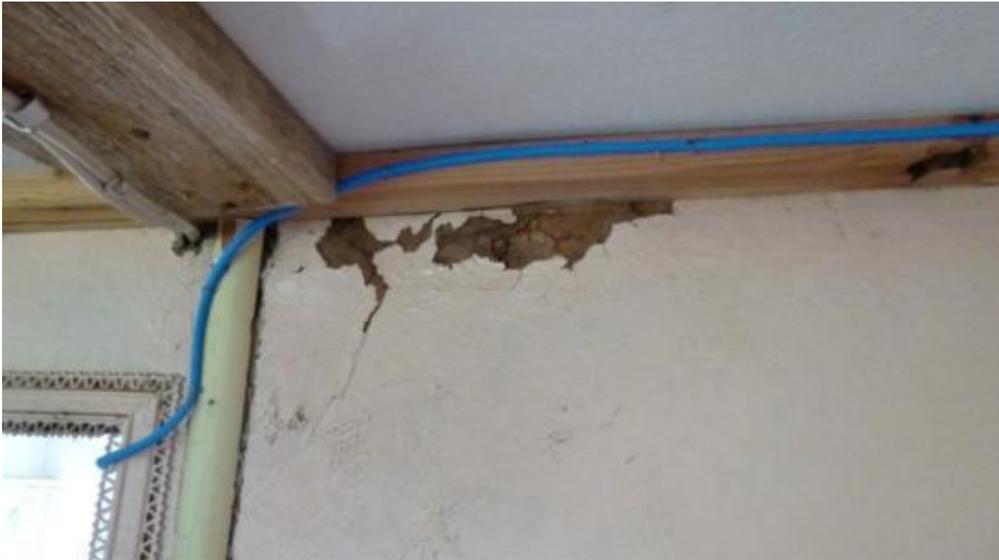
Figure 144. Ceiling in bedroom, east wall, GB March 2014

The cornice along the western wall is a 70 x 18 planted to the wall with a “D” moulding below. Across the eastern wall the cornice is an unpainted 70 x 18 board. Across the northern wall the cornice is a planted rectangular board on the wall with a 70 x 18 planted moulding to the ceiling. There is no cornice moulding along the south wall. An exposed electrical wire runs across the intersection of the wall and ceiling on the northern wall and down the north west corner to a power outlet set just above the skirting on the north wall.

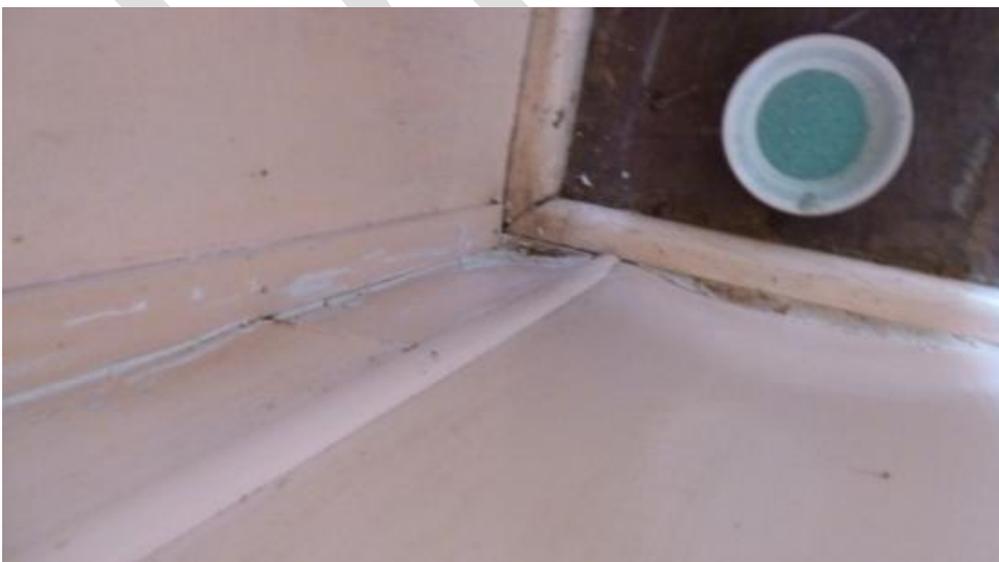
Figure 146. Floor / wall south west corner, GB March 2014

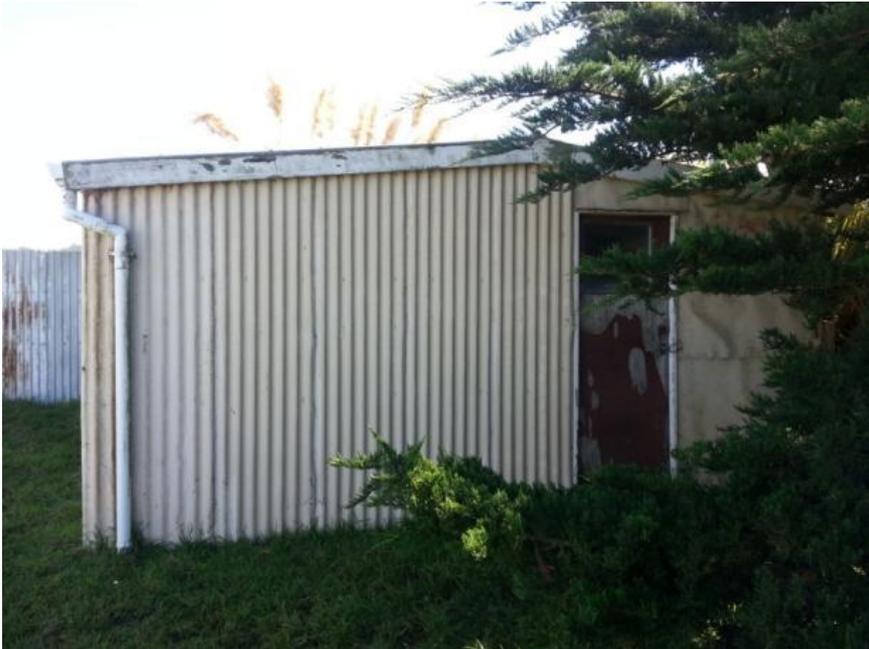
Figure 147. East elevation of the shed, LK March 2014

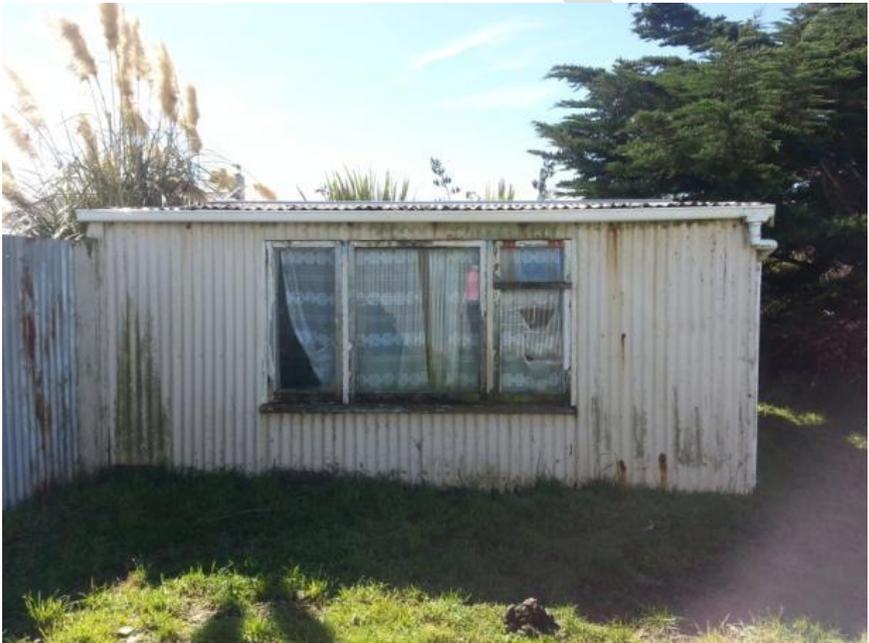
Figure 148. South elevation of the shed, LK March 2014

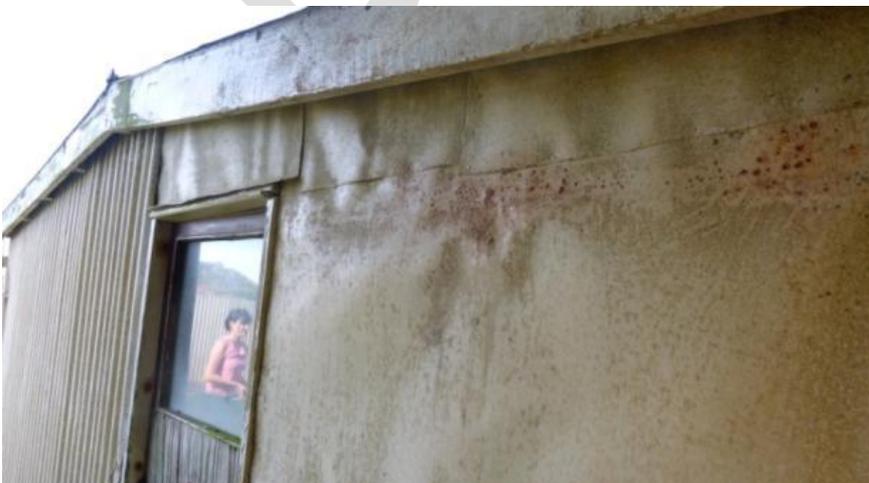
Figure 149. East wall showing material junctions, LK March 2014

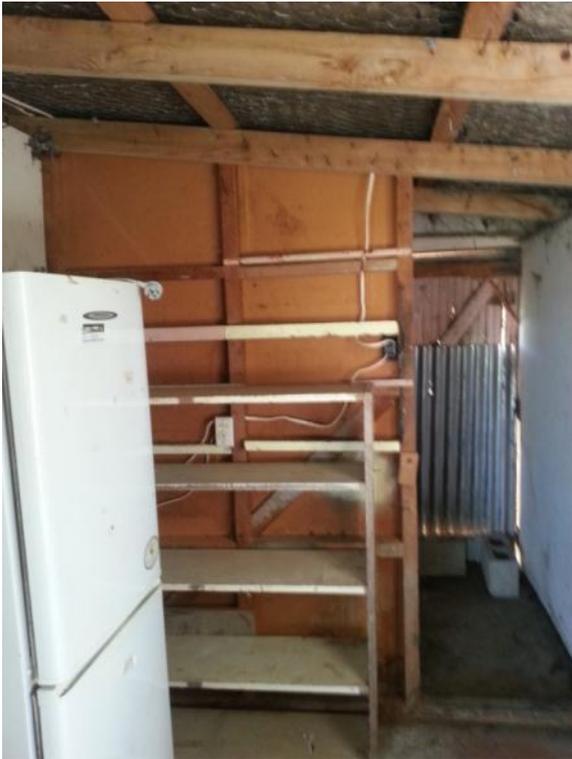
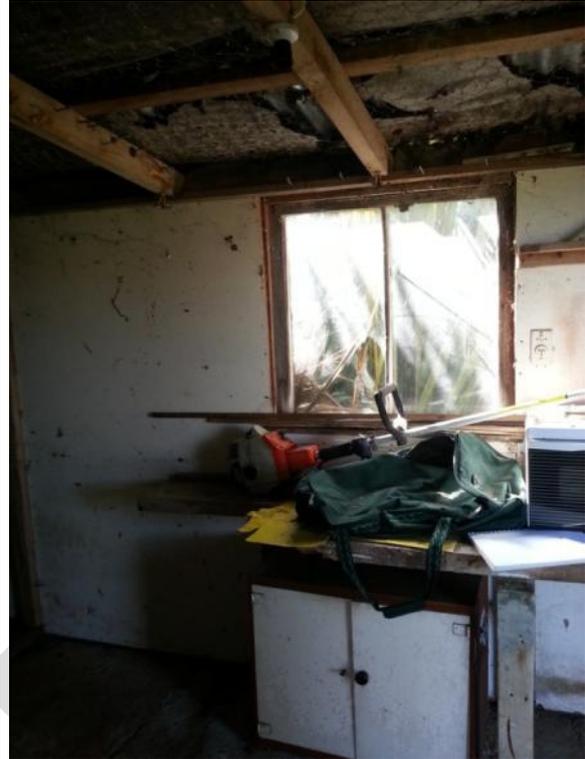
Figure 154. Entry room looking through to back room showing exposed rafters and wall framing (left) Figure 155. Exterior north wall showing window and shelves (right) LK March 2014

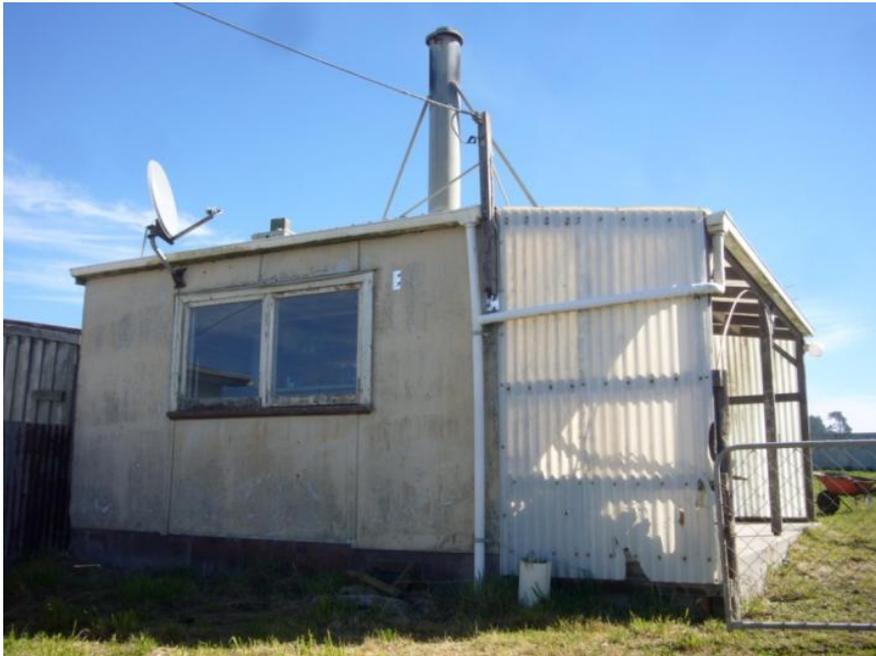
Figure 161. East Elevation of the crib, LK March 2014

The sheeting is cracked and broken in places. At the intersection with the vertical hardwood batten that holds the power connection (east elevation), the movement of the batten, which has rotted at the base, has caused the cladding to crack.

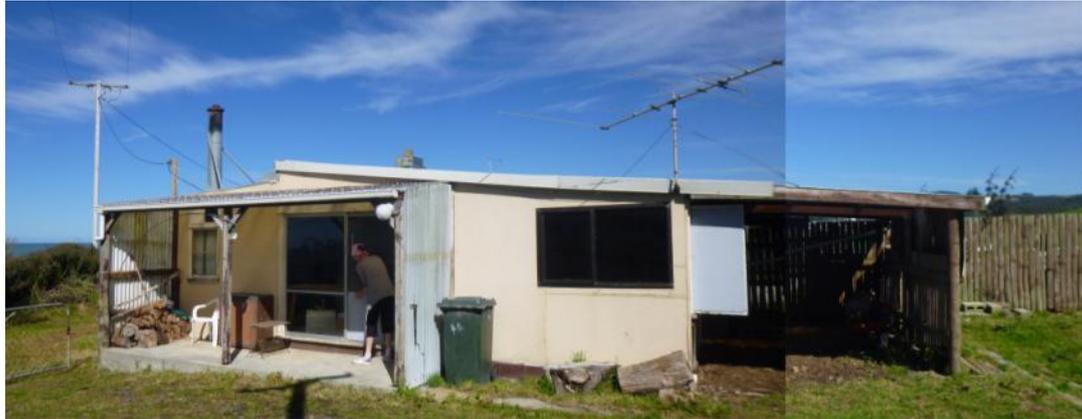
Figure 163. North Elevation of the crib, LK March 2014

General Finishes	<i>refer overall</i>
Lean-to verandah	
<i>Corrugated plastic roof</i>	1
<i>Timber framing</i>	1
<i>Corrugated plastic end panels</i>	1
<i>Globe light</i>	1
<i>Concrete base</i>	1
<i>Polyethylene pipe</i>	1
Meter board	1
Enclosed window	1
Ranch Slider	1
Aluminium window to bedroom	1
Television Aerial	1

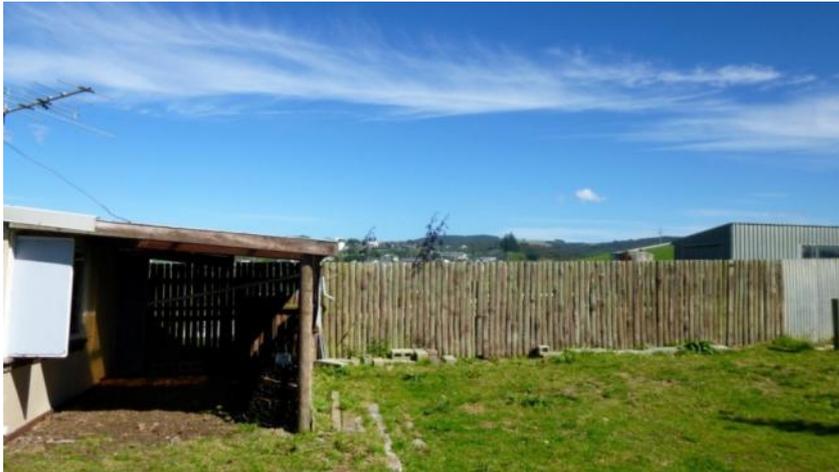
Figure 164. North elevation of lean to carport showing south boundary fence GB March 2014

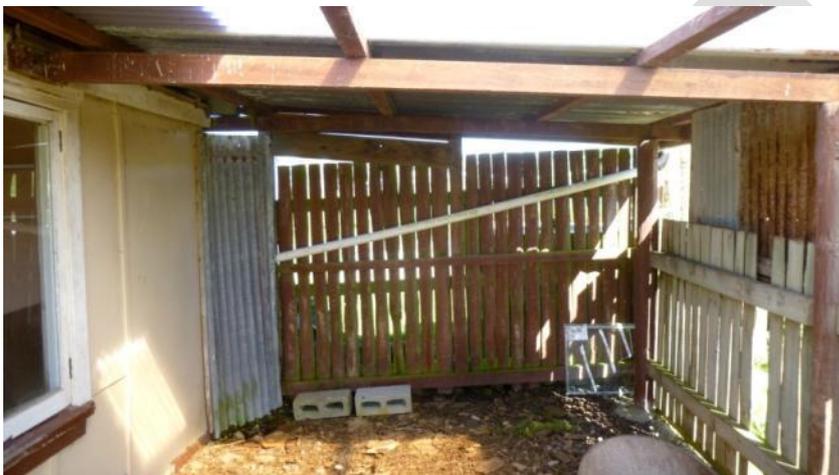
Figure 165. South wall of lean to carport GB March 2014

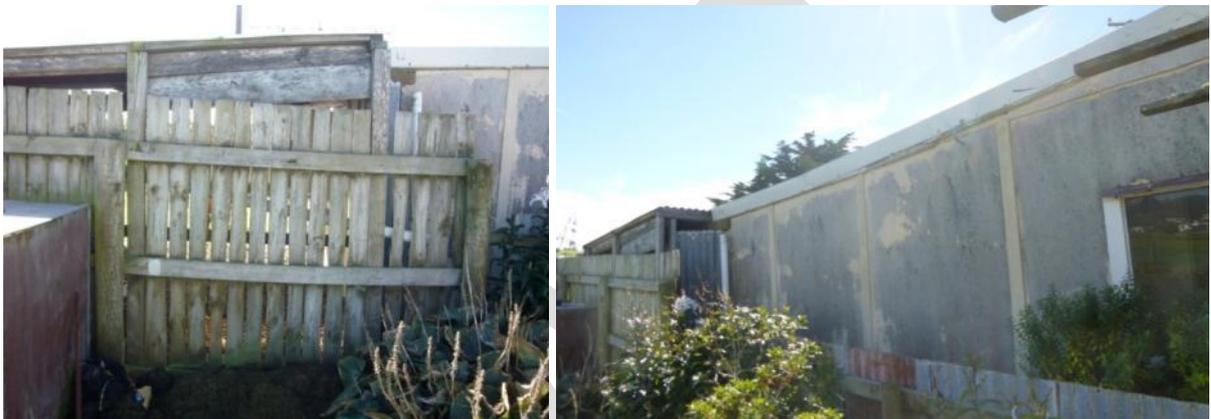
Figure 169. South wall of lean to carport (left) Figure 170. South wall of crib. view from neighbouring property looking west. LK March 2014

General Finishes	<i>refer overall</i>
Bathroom- timber window	1
Kitchen- timber window	1
Piping to header tank	3
Old header tank connections	3
WC waste penetration + connection	neut.

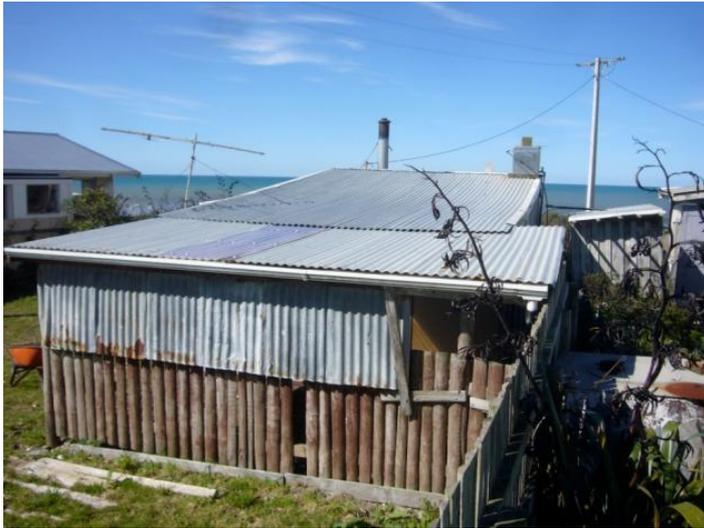
Figure 171. View east over roof of the crib and carport lean to, GB March 2014

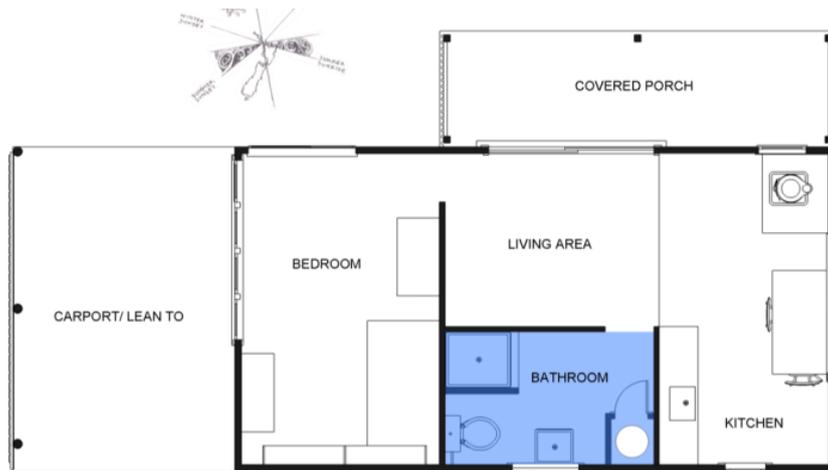
Figure 173. Crib Floor Plan, B&T Architects LK March 2014

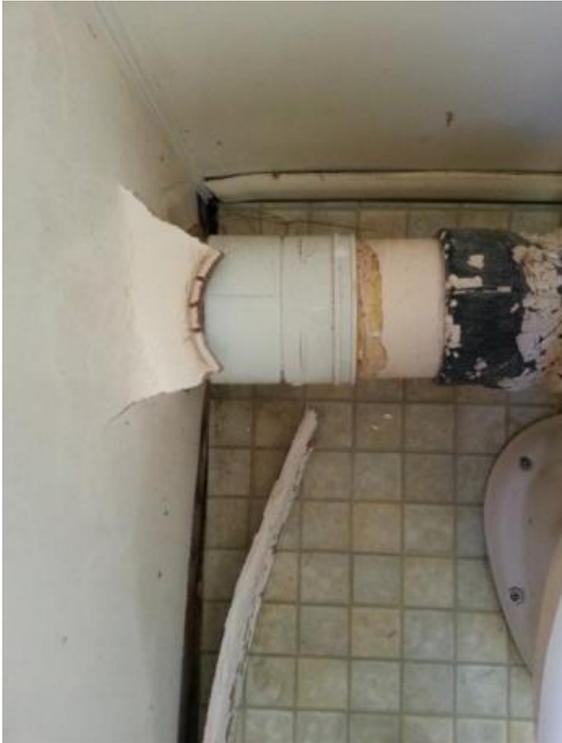
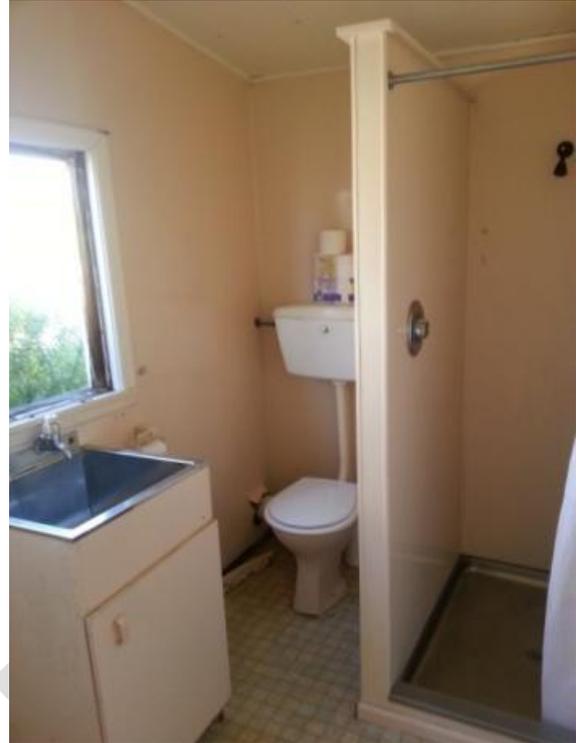
Figure 174. Pipe from WC & peeling skirting board (left) Figure 175. Bathroom south west corner (right) LK March 2014

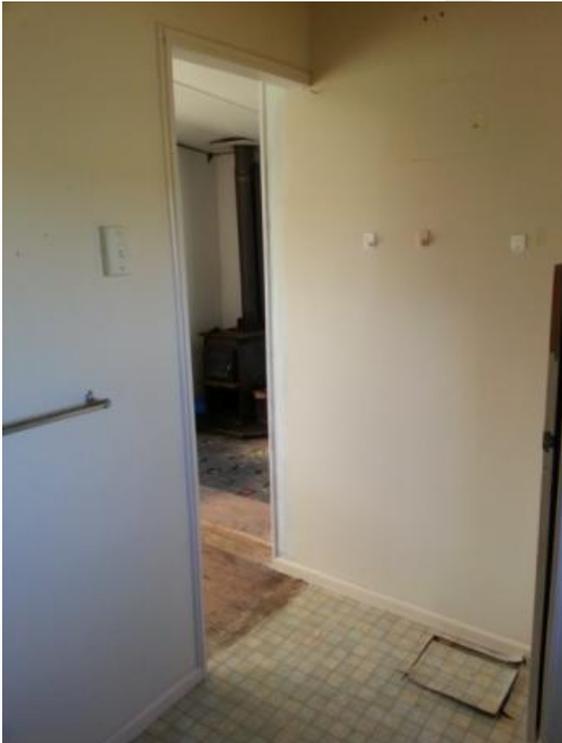
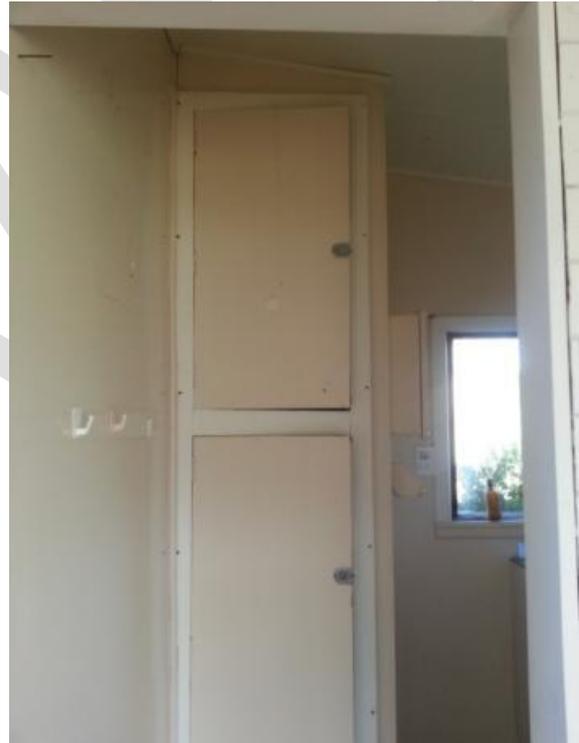
Figure 176. North east corner showing doorway into living area (left) Figure 177. HWC cupboard (right) LK March 2014

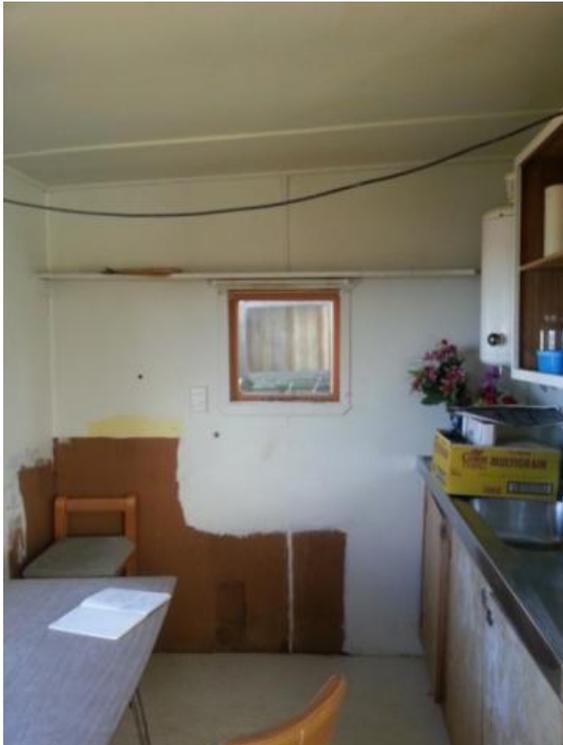
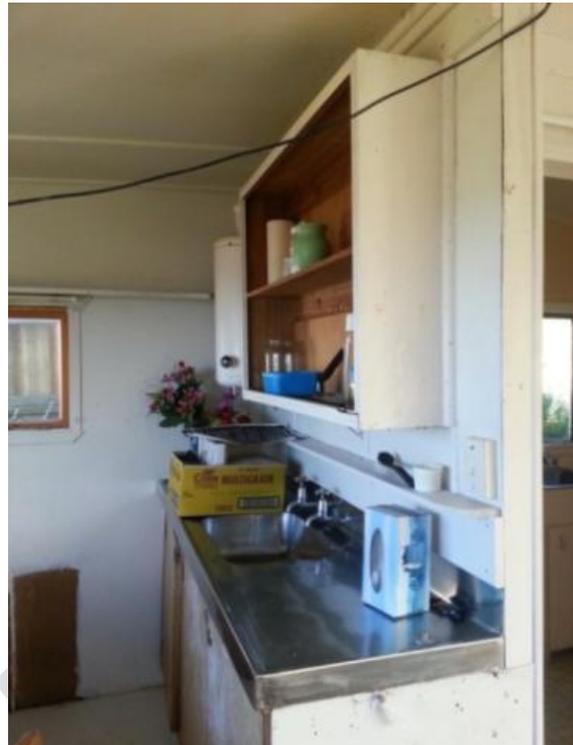
Stainless steel bench with single sink	1
Plain wall mount chrome taps	1
Rimu and rimu ply bench unit	1
Timber shelf above bench upstand	1
Wall hung painted cupboard unit	1
Wall mounted boiler unit	1

Figure 179. South wall of the kitchen area showing table (left) Figure 180. South west corner showing kitchen cabinetry (right) LK March 2014

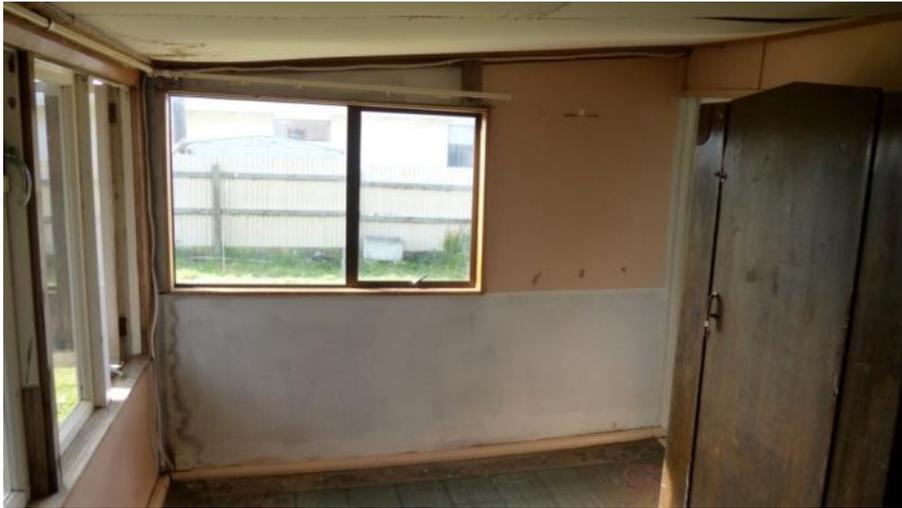
Figure 182. North wall of bedroom, GB March 2014

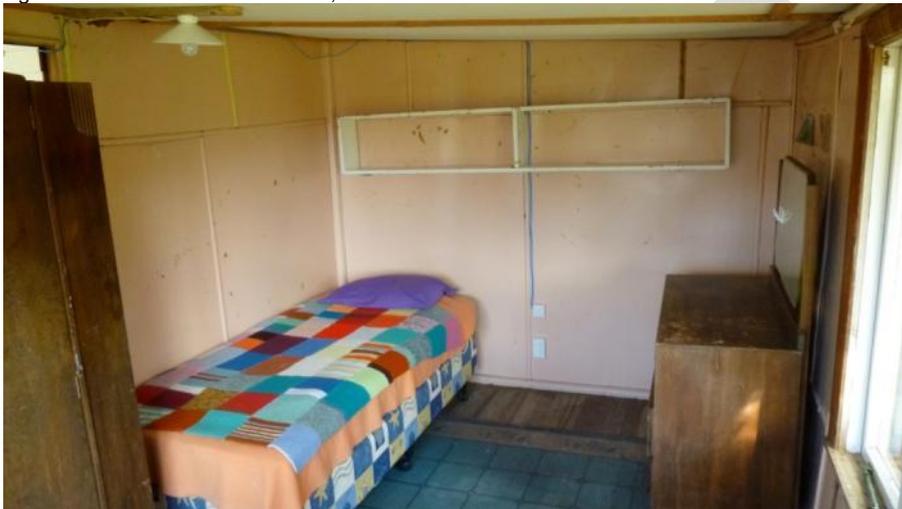
Figure 183. South wall of bedroom, GB March 2014

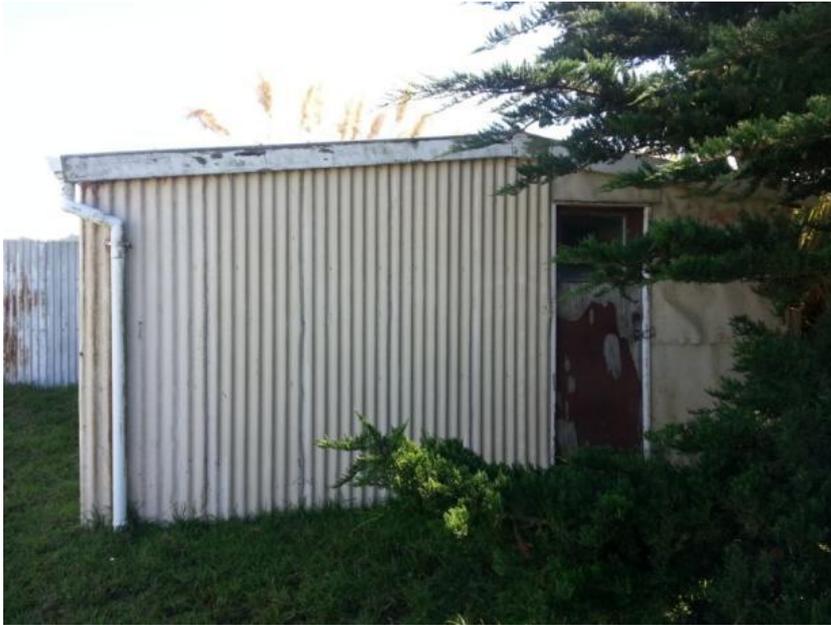
Figure 184. East elevation of the shed, LK March 2014

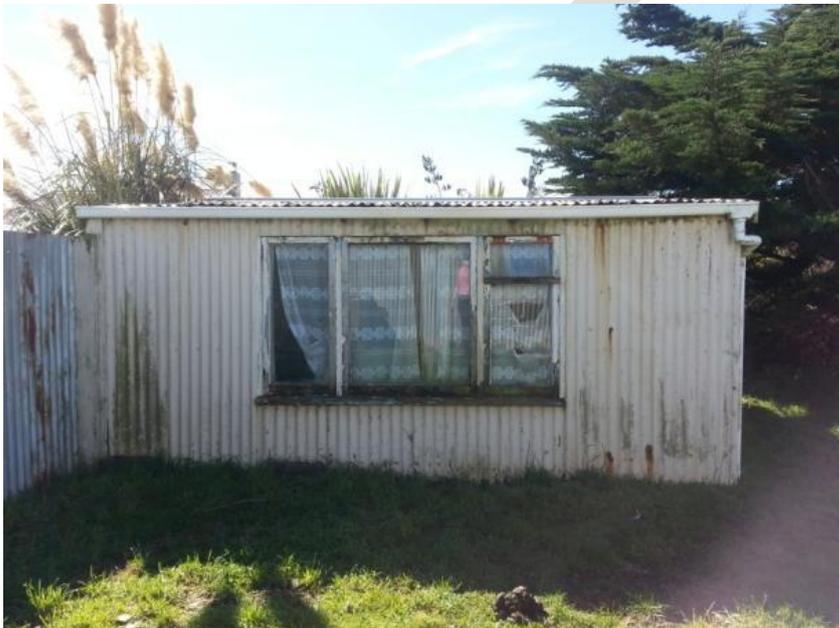
Figure 185. South elevation of the shed, LK March 2014

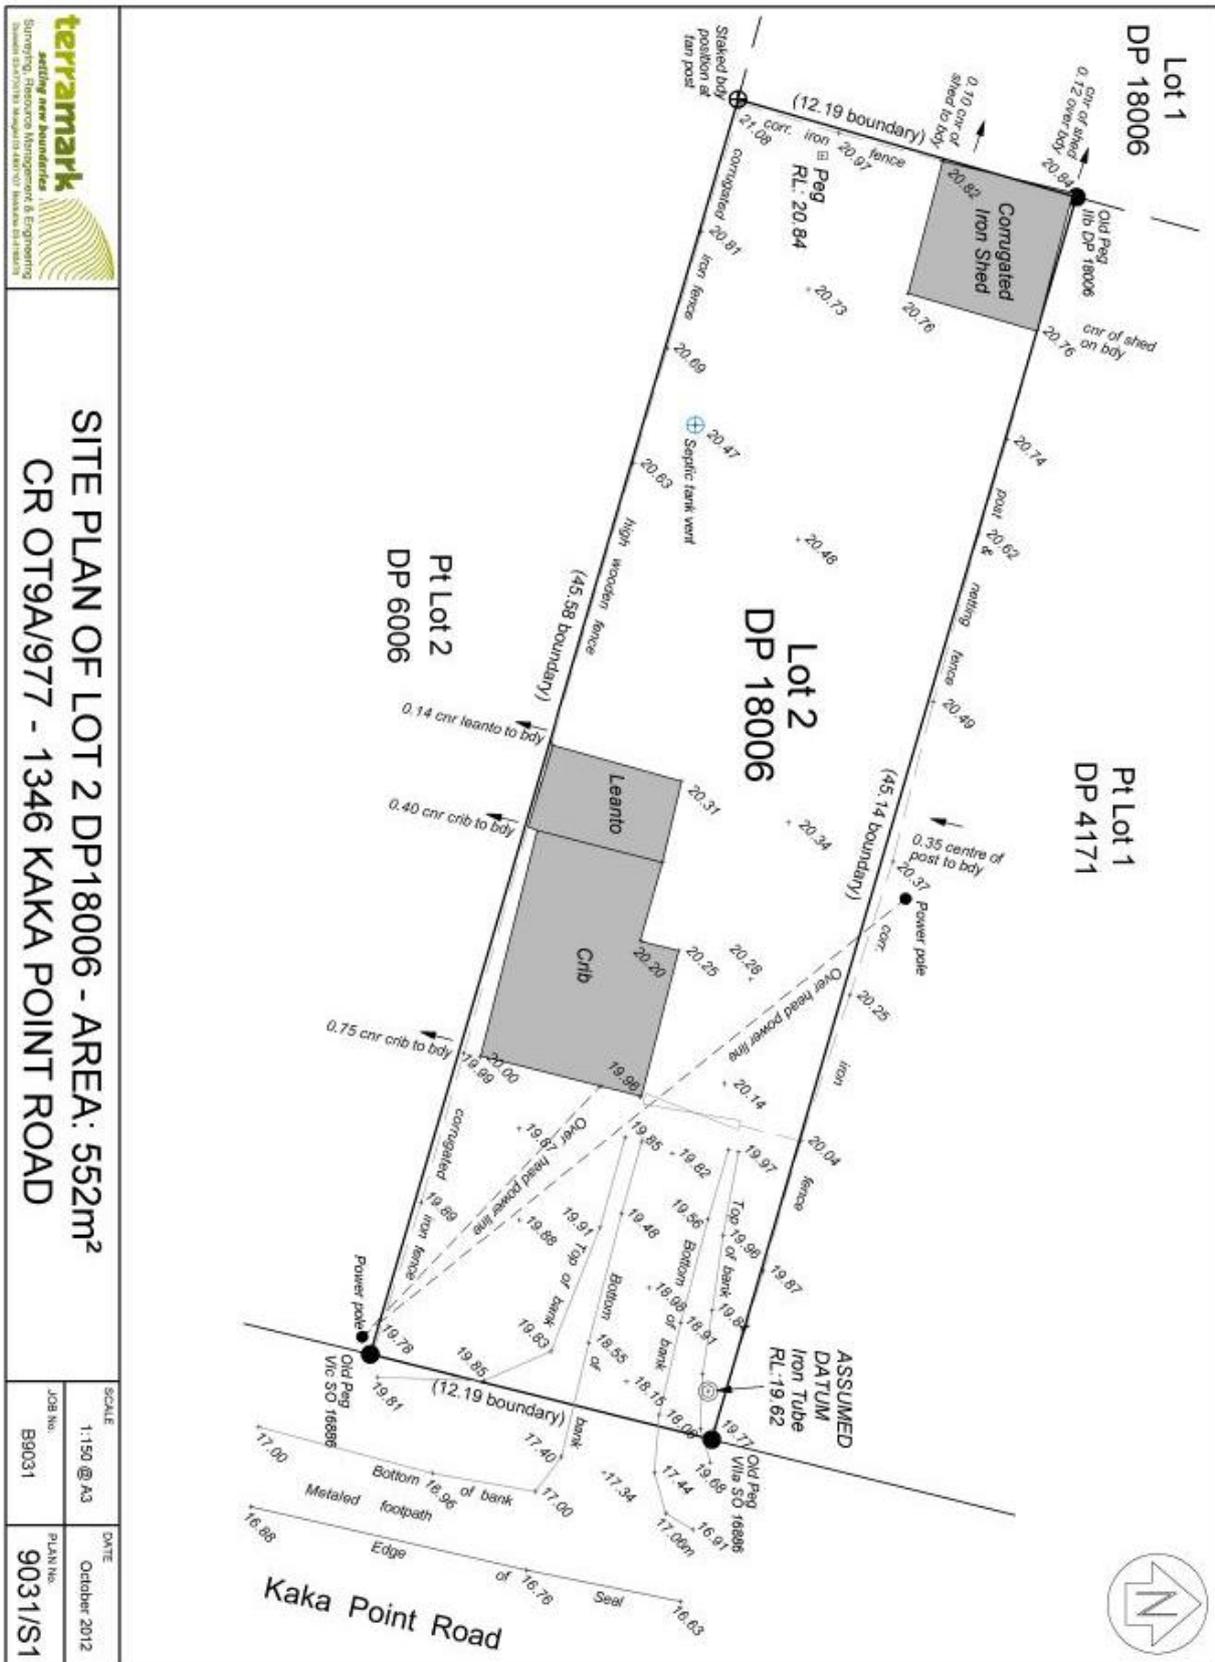
SITE PLAN OF LOT 2 DP 18006 - AREA: 552m²
CR OT9A/977 - 1346 KAKA POINT ROAD
